Waterbody Data Sheet

Description			
Project Name: Line 5 Relocation Project		Date: 2019-09-24	Waterbody Survey ID: sase006p
State: WI	County/Parish: Ashland	USGS Waterbody Name: Bay City Creek	
Company: Enbridge	Crew Member Initials: KDF/ARK	Latitude: 46.551127	Longitude: -90.895194
Survey Type: <input checked="" type="checkbox"/> Centerline <input type="checkbox"/> Re-Route <input type="checkbox"/> Access Road <input type="checkbox"/> Facility <input type="checkbox"/> Other <small>(check one)</small>			
Waterbody Type: <input type="checkbox"/> River <input checked="" type="checkbox"/> Stream <input type="checkbox"/> Ditch <input type="checkbox"/> Swale <input type="checkbox"/> Canal <input type="checkbox"/> Other <small>(check one)</small>			
Water Appearance: <input type="checkbox"/> No Water <input checked="" type="checkbox"/> Clear <input type="checkbox"/> Turbid <input type="checkbox"/> Sheen on Surface <input type="checkbox"/> Surface Scum <input type="checkbox"/> Algal Mats <input type="checkbox"/> Other <small>(check one)</small>

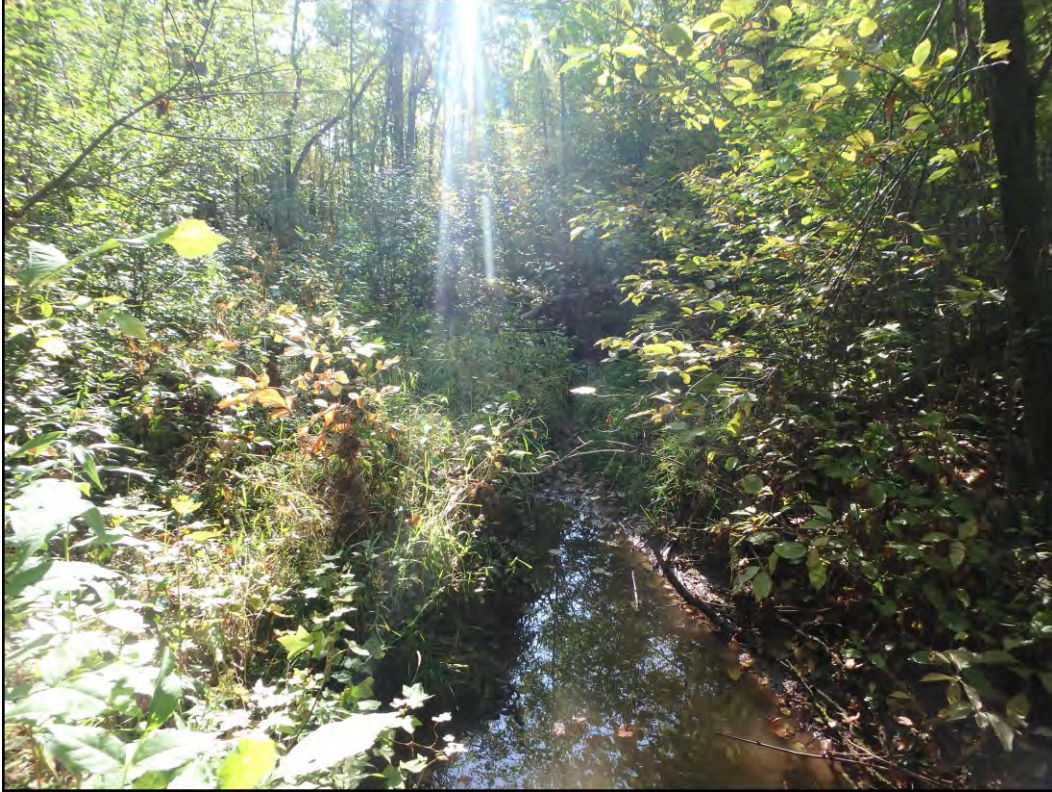
sasa047i_E (downstream)

Existing Condition^a: <input type="checkbox"/> Highly Functional Stream <input type="checkbox"/> Moderately Functional Stream <input checked="" type="checkbox"/> Functionally Impaired Stream <small>(check one)</small>			
Feature Description: <input checked="" type="checkbox"/> Natural <input type="checkbox"/> Artificial, man-made <input type="checkbox"/> Manipulated <small>(check one)</small>			
Flow Regime: <input type="checkbox"/> Ephemeral <input checked="" type="checkbox"/> Intermittent <input type="checkbox"/> Perennial <input type="checkbox"/> Connecting Swale <small>(check one)</small>			
Sinuosity within Survey Corridor: <input type="checkbox"/> Straight <input checked="" type="checkbox"/> Meandering <small>(check one)</small>			
Description Notes: The waterbody is an intermittent stream that meanders through a densely wooded forest. Area has been disturbed due to cattle grazing. Debris and logs are washed up along the banks of the stream.

Observations			
Riparian Zone Present: <input type="checkbox"/> Yes <input checked="" type="checkbox"/> No <small>(check one)</small>			
Vegetation Layers: <input checked="" type="checkbox"/> Trees <input checked="" type="checkbox"/> Saplings/Shrubs <input checked="" type="checkbox"/> Herbs <small>(check all that apply)</small>			
Dominant Bank Vegetation (list): Fraxinus nigra, Rhamnus cathartica, Carex intumescens.			
Aquatic Habitats (ex: submerged or emerged aquatic vegetation, overhanging banks/roots, leaf packs, large submerged wood, riffles, deep pools, etc.): Pools of standing water.			
Aquatic Organisms Observed (list): None.			
Disturbances (ex: livestock access, manure in waterbody, waste discharge pipes): Cattle grazing.			
Observation Notes: Currently, no water is flowing, but some standing water is pooled.

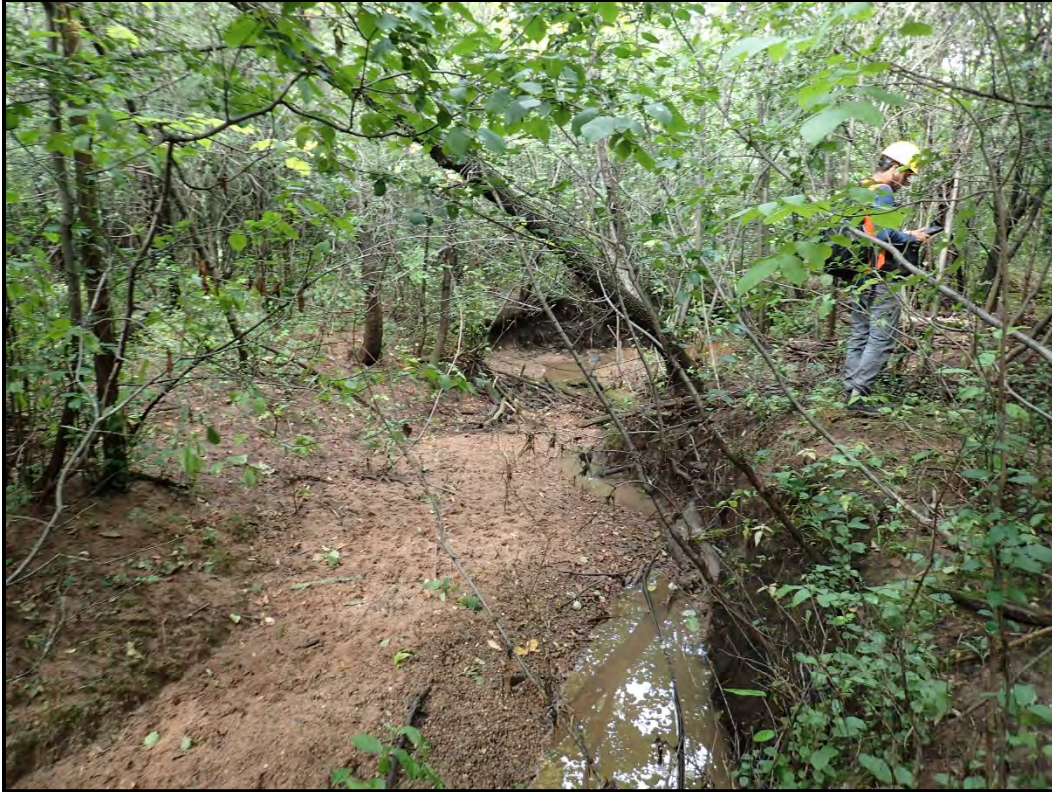
sasb007i_NW (downstream)

Vegetation Layers: <input type="checkbox"/> Trees <input checked="" type="checkbox"/> Saplings/Shrubs <input checked="" type="checkbox"/> Herbs <i>(check all that apply)</i>			
Dominant Bank Vegetation (list): Bank vegetation dominated by Rhamnus cathartica, Crataegus sp., and Alnus incana.			
Aquatic Habitats (ex: submerged or emerged aquatic vegetation, overhanging banks/roots, leaf packs, large submerged wood, riffles, deep pools, etc.): Pools of water.			
Aquatic Organisms Observed (list): Water striders, frogs.			
Disturbances (ex: livestock access, manure in waterbody, waste discharge pipes): Erosion, invasive species.			
Observation Notes: None.

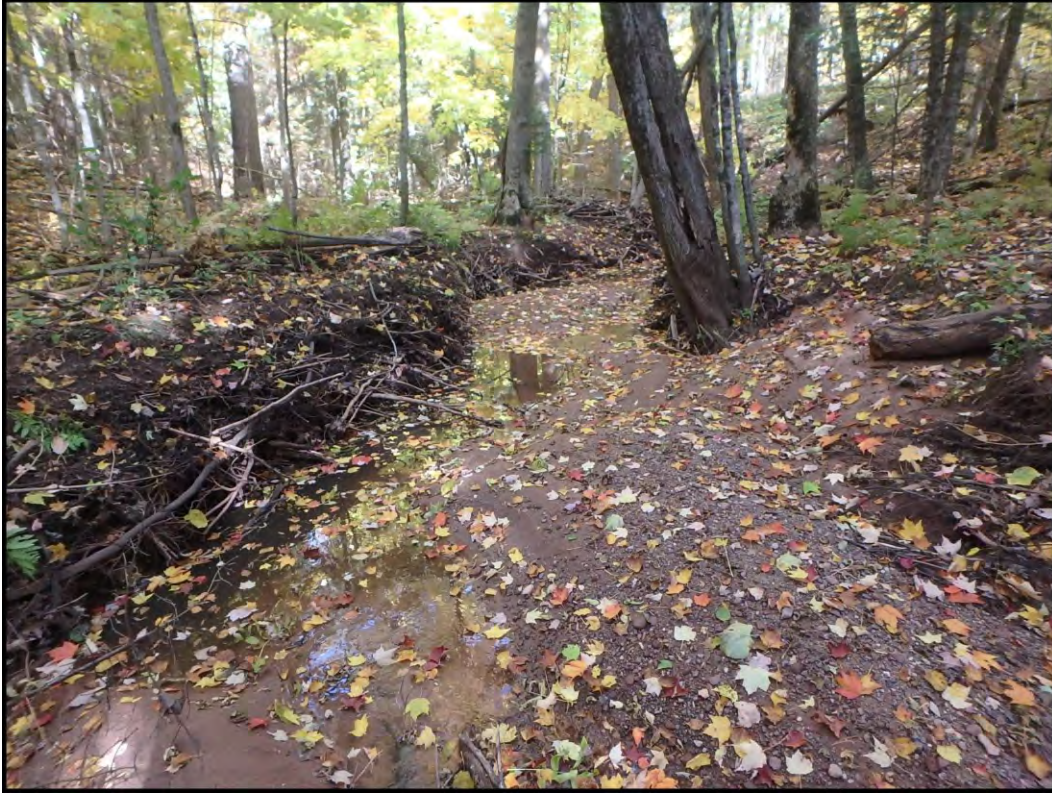
sasc039i_E (downstream)

Vegetation Layers: <input checked="" type="checkbox"/> Trees <input checked="" type="checkbox"/> Saplings/Shrubs <input checked="" type="checkbox"/> Herbs <i>(check all that apply)</i>			
Dominant Bank Vegetation (list): Acer rubrum, Thuja occidentalis, Tsuga canadensis, Fraxinus nigra, Abies balsamea, Athyrium filix-femina, Carex pedunculata, Rhamnus cathartica, Osmunda claytoniana.			
Aquatic Habitats (ex: submerged or emerged aquatic vegetation, overhanging banks/roots, leaf packs, large submerged wood, riffles, deep pools, etc.): Woody debris.			
Aquatic Organisms Observed (list): None.			
Disturbances (ex: livestock access, manure in waterbody, waste discharge pipes): Runoff from nearby crop field.			
Observation Notes: The feature is highly erosional, with sparse bank vegetation.

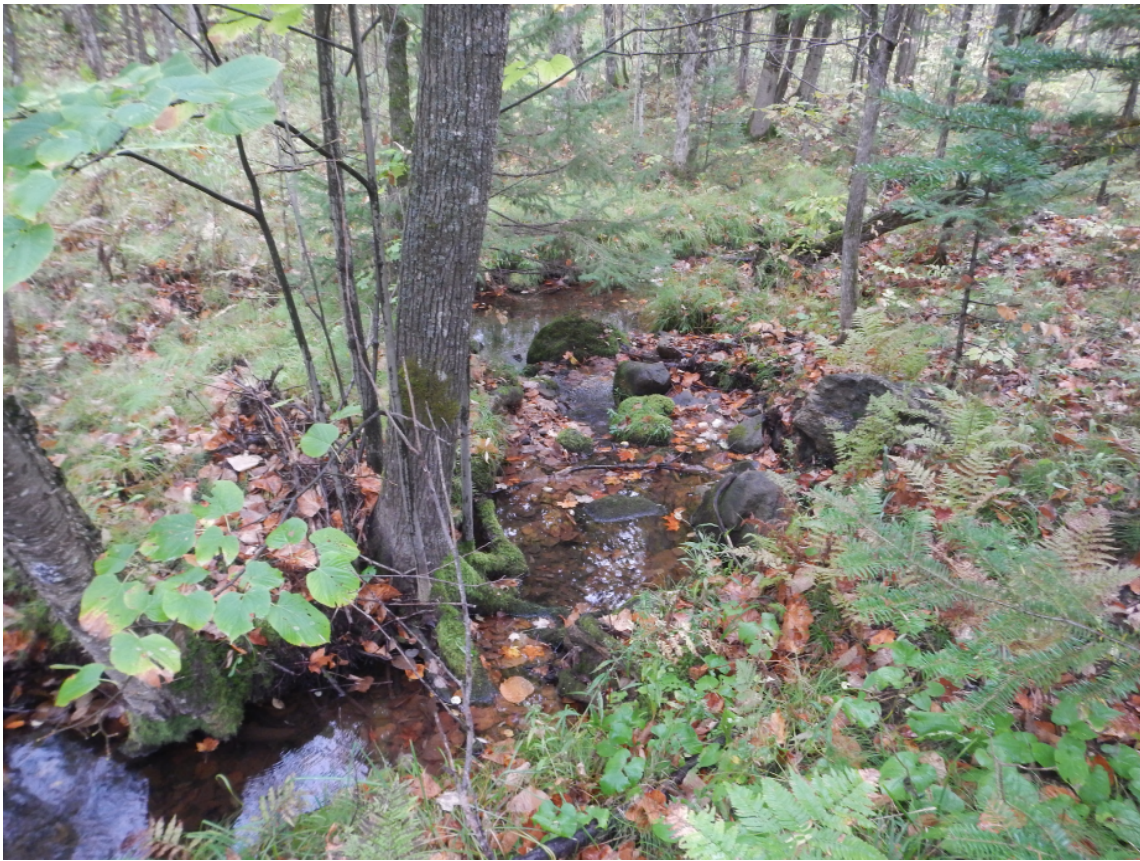
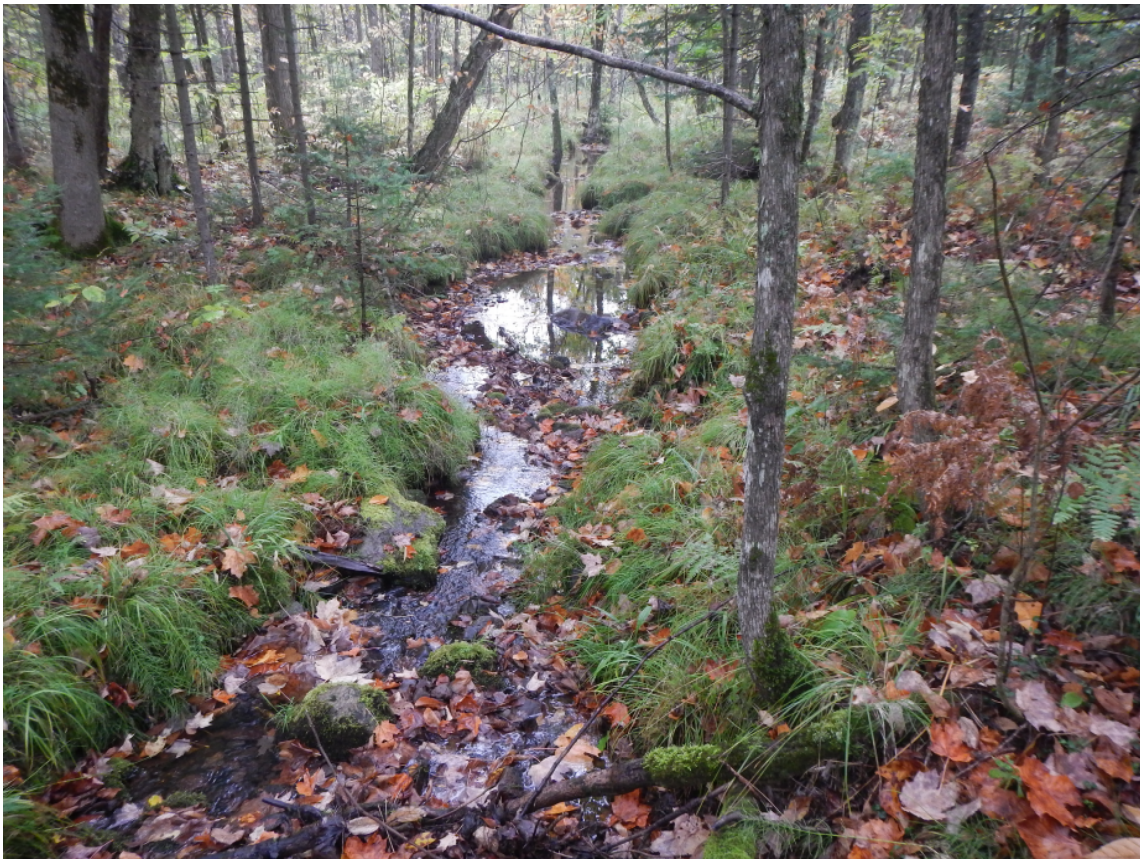
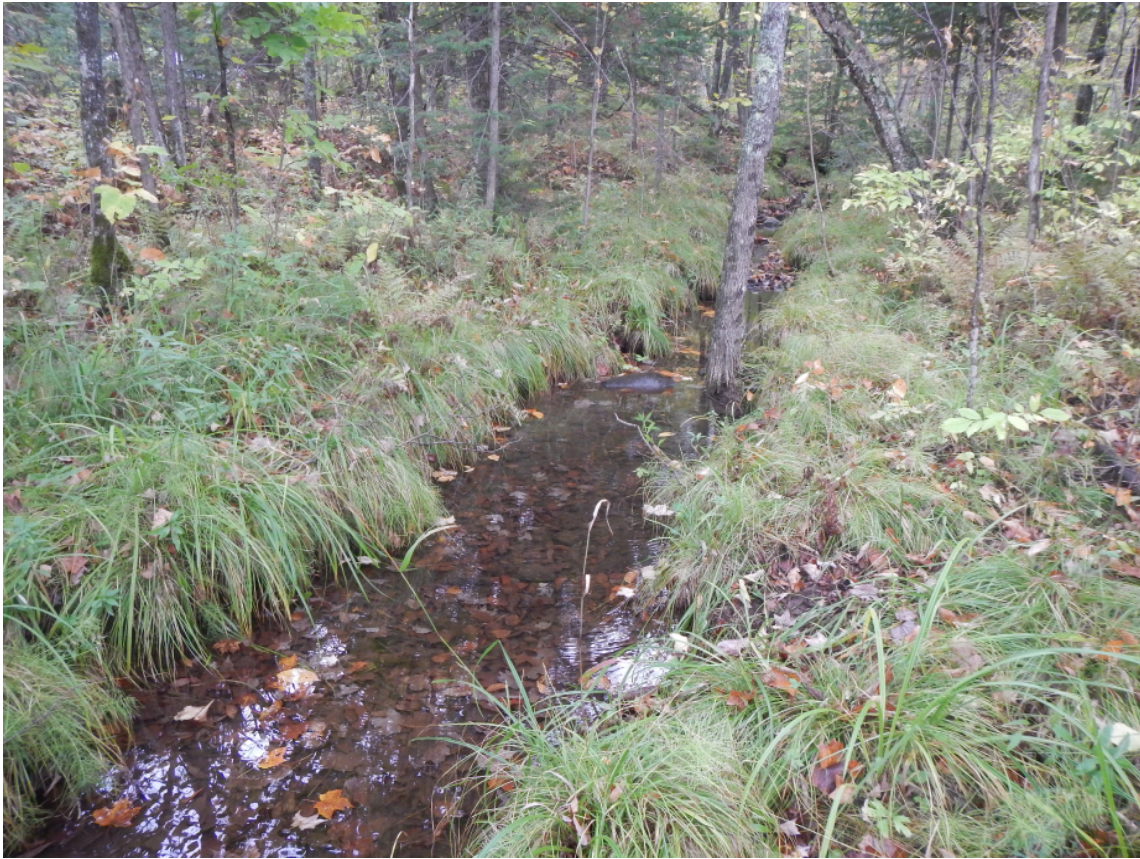
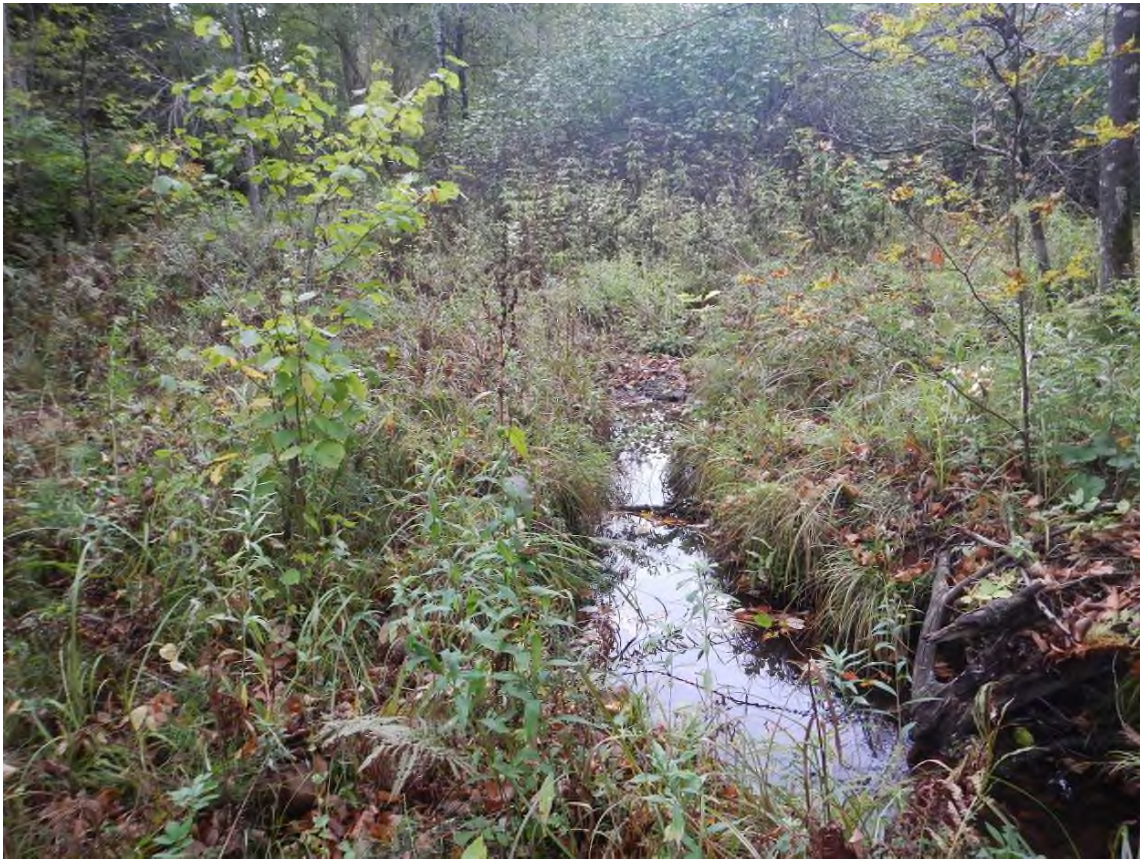
sasw011

High quality, natural stream flows through hummock/tussock forested wetland and alder thicket scrub-shrub wetland
