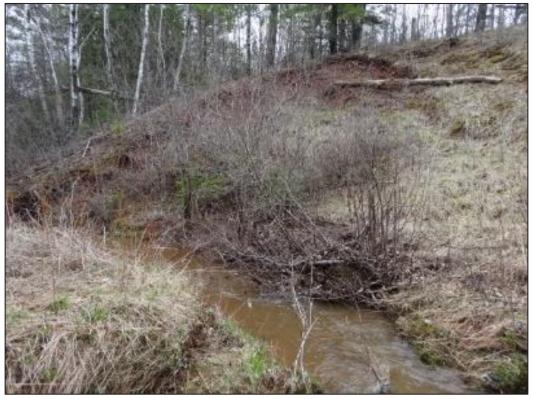
MP 0.63 Bay City Creek (sase006p)

Photo looking northeast at existing slope instability area.

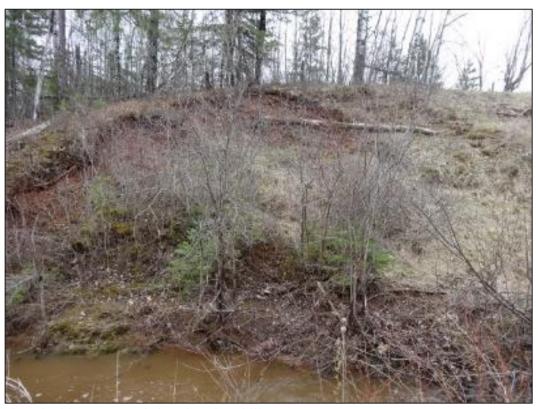
Photo looking east at existing slope instability area.
