Alice Thompson, MS, SPWS

Thompson & Associates Wetland Services. LLC
1514 Menomonee Ave.
South Milwaukee WI 53172
414-571-8383

April 20, 2023

ADDENDUM TO REVIEW OF ENBRIDGE LINE 5 WISCONSIN SEGMENT RELOCATION PROJECT
FIELD REVIEW SEPTEMBER 26-27, 2022

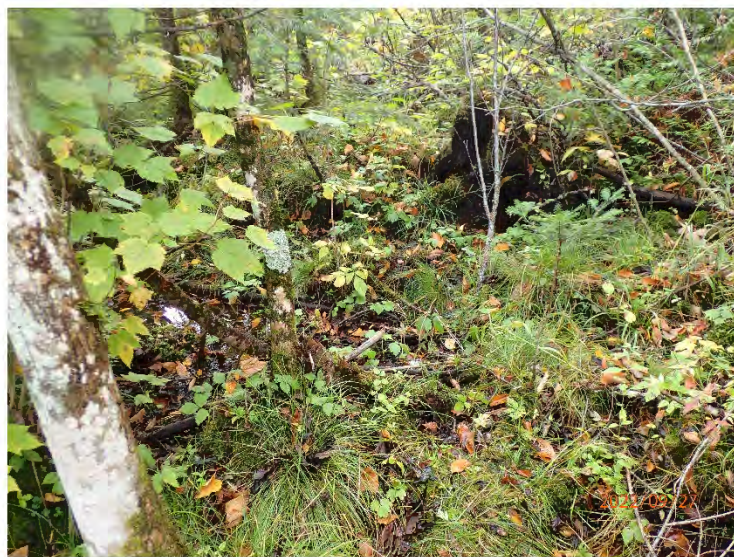
Figure 1. Wetland complex wirc013f_x.

The wetland system south of Vogues Road, Wetland **wirc013f_x** (description starting on page 18 below) is a stunning wetland with at least two orchid species, and a plethora of native trees, shrubs, and forbs including mature northern white cedar and mature black ash. The habitat had pools of standing water and a running rivulets of water that do not appear on the company maps. Because this wetland is proposed for open trenching, along with many other forested wetlands in this project, there is high risk of decades or more of damage to the structure, functions and wildlife that inhabit this wetland, both within the immediate construction corridor and outside of it.

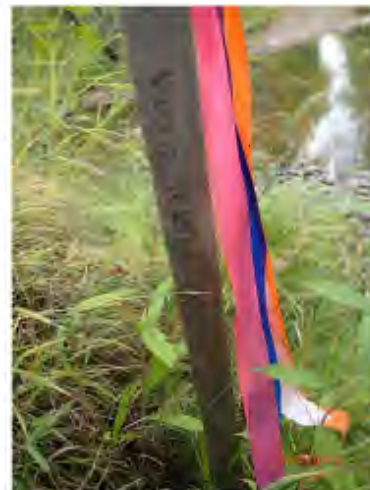
Figure 3. Wood Turtle Habitat Stake

Tyler Forks (sirb012p) banks showed multiple **"Wood Turtle Habitat"** stakes. The river water was clear with iron-stained water. The bottom cobble was visible.

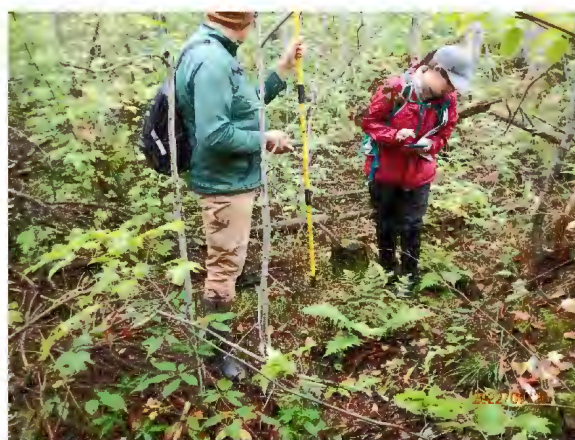
Figure 4. MW 2022_A west of AR 083

The forest trail AR 083 is proposed to be used during Line 5 construction. The trail had an unreported wetland at just west of the trail and within the survey corridor approximately 385 feet north of Casey Sag Road. (BE Wetland 1, Line1). The wetland **MW 2022_A** extends west of the forest road and consisted of *Populus tremuloides* (quacking aspen) and *Ilex verticillata* (winterberry) in the tree and shrub layer and *Glyceria striata* (fowl manna grass), *Dryopteris carthusiana* (spinulose wood fern), and *Rubus pubescens* (dwarf red raspberry) in the ground layer. A ruffed grouse drumming was heard. Wetland soils were 15" to bedrock.

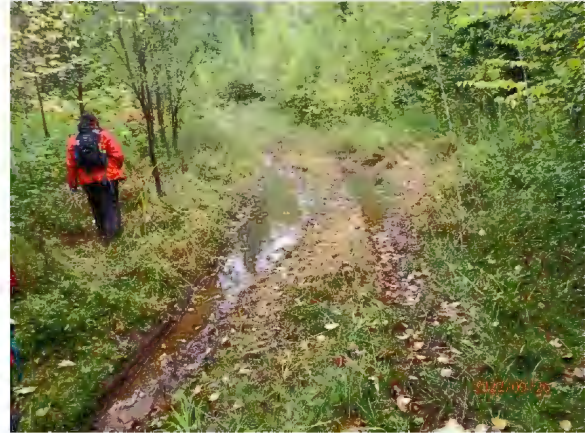
Figure 5. Wirb040_e: Standing water in trail ruts.

North on AR 083 wetland **Wirb 040e** crosses the trail and joins **Wirb 040f**. Vegetation included *Typha sp.* (cattail), fowl manna grass, *Carex gynandra* (nodding sedge), *Cleome glabra* (turtlehead), *Verbena hastata* (blue vervain), *Persicaria sagittata* (tear thumb), and *Impatiens capensis* (jewel weed). There was standing water in ruts on the trail (Figure 5). There is a drainage feature, mapped by GLIFWC that is unreported on Enbridge mapping.

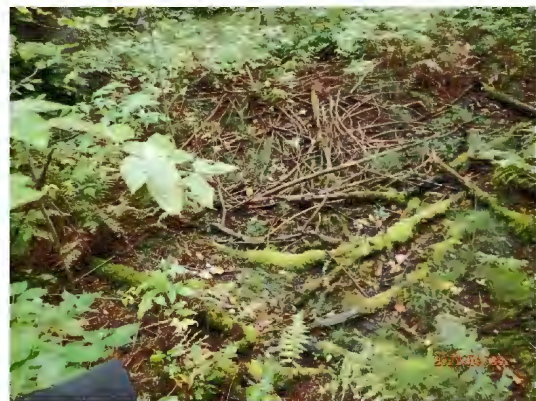
Figure 6. MW2022_B

Northeast of Wirb 041e_w and close to the junction of the trail to the proposed pipeline route is a **missed wetland MW2022_B** (BE Wetland 2) that is outside the trail but well within the company survey corridor. Missed wetlands are a concern even outside the presumed company workspace disturbance width due to the possible construction impacts including but not limited to spoils, erosional deposition, trench water flow, and equipment or materials staging.

This wetland was a concave basin with blackened leaves. It had downed logs with moss, *Fraxinus nigra* (black ash) seedlings, *Equisetum sylvaticum* (woodland horsetail), *Athyrium filix-femina* (Lady fern), and *Onoclea sensibilis* (sensitive fern), Wetland soils were 15 inches to bedrock.

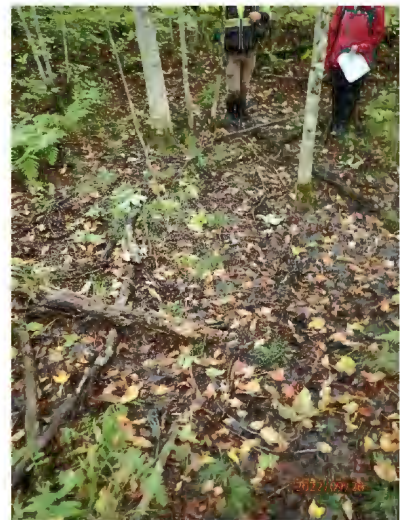
Figure 7. Missed wetland MW2022_C

Missed wetland MW2022_C (BE3) was not delineated by the company. It is a WWI point “too small to delineate” within the company mapped workspace and well within the delineated survey corridor.

The wetland was a concave basin with blackened leaves and watermarks on trees at 11” above the ground. Trees had buttressed roots. Vegetation included woodland horsetail, Lady fern, *Carex*

intumescens (bladder sedge) and *Parthenocissus quinquefolia* (Virginia creeper). Wetland soils were 24.5 inches to rock. *Thuja occidentalis* or Northern white cedar seedlings were found in and adjacent the wetland. A *Pseudacris crucifer* (spring peeper) was observed.

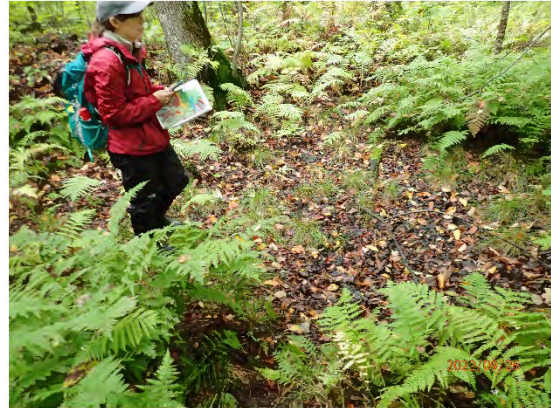
Figure 8. MW 2022_D

Missed wetland MW 2022_D (BE Basin 1) was not delineated by the company, and is found west of the centerline of the proposed pipe and south of **wirb038e_w**. It is within company mapped workspace. It was a concave basin with blackened leaves. Vegetation included woodland horsetail, Lady fern, and *Deparia acrostichoides* (silvery speenwort).

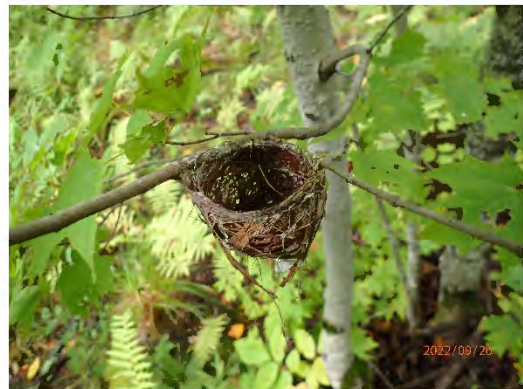
Figure 9. Songbird nest 2 1/4" across, 2" deep

A delicate songbird nest was found 4 feet off the ground in a sugar maple sapling that was woven of thin fibers and sheds of birchbark (Figure 9).

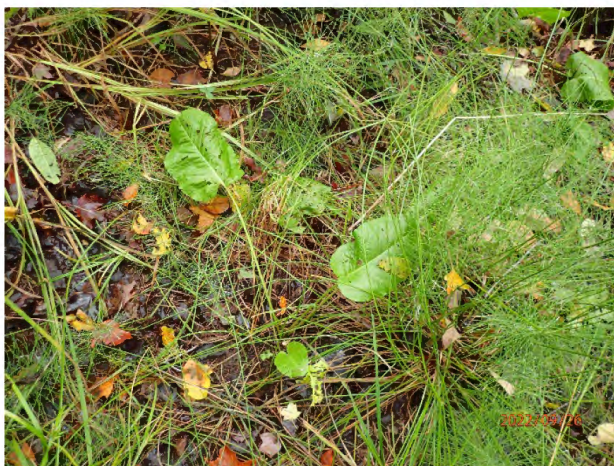
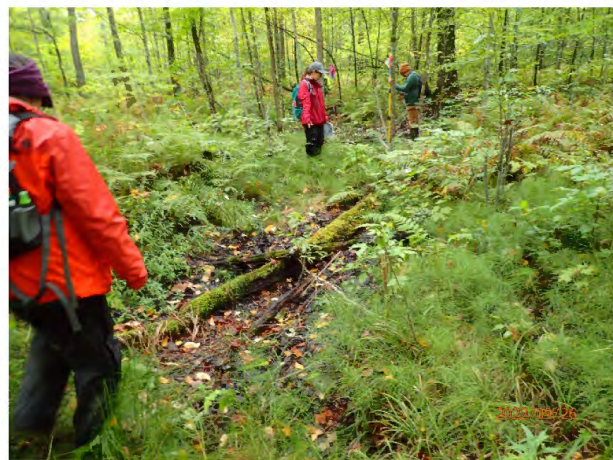
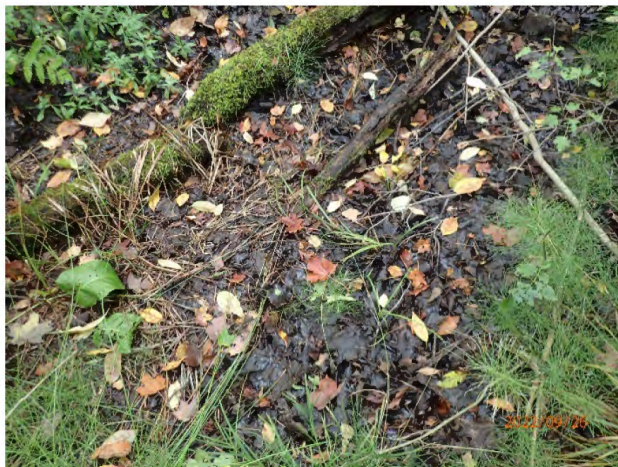
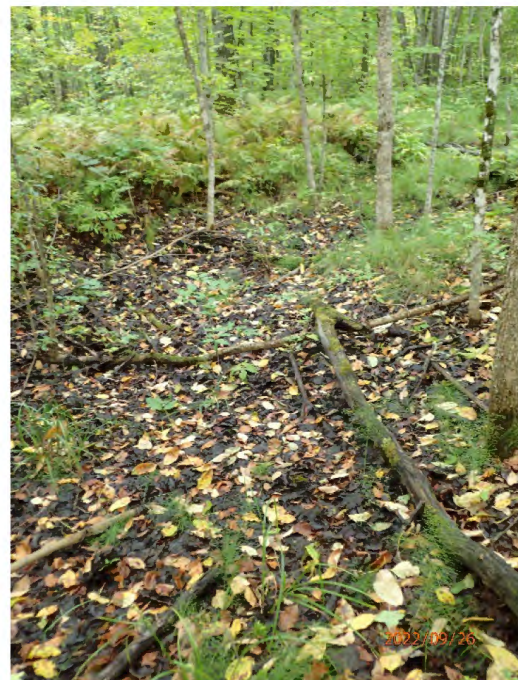
Missed Wetland **MW 2002_F** (BE Track 5, 6) were basins west and southwest of wirb035e_w. They were concave basins with blackened leaves, buttressed tree roots, and high water marks on trees. Vegetation included black ash in the overstory, *Scheonoplectus tabernaemontani* (soft-stem bulrush), bladder sedge, *Rumex britannica* (great water dock), and woodland horsetail. Spring peepers were observed.

Figure 15. MW 2022_F

Figure 16. MW 2022_F - a long connected series of basins

Figure 14. MW 2022_F- Blackened leaves, woodland horsetail and great dock

Figure 17. Missed Wetland MW2022_F

This Missing Wetland MW 2002_F continues east of the pipeline corridor as a basin with blackened leaves. Water marks were 16 inches above soil surface on black ash.

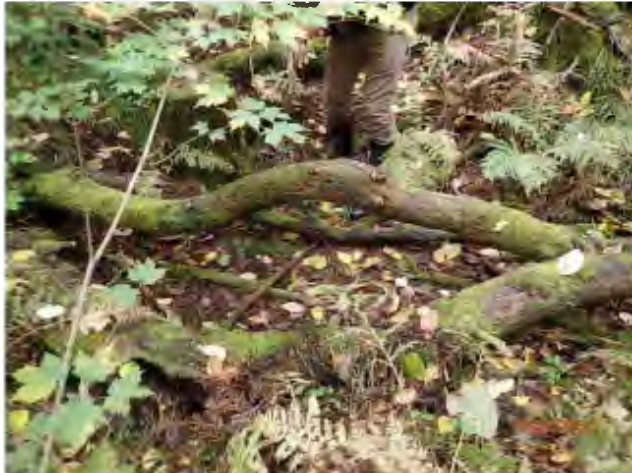
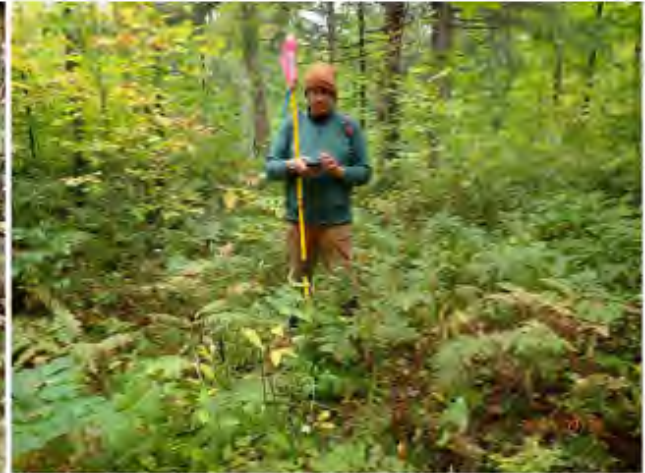
Figure 22 Possible MW 2022_G on centerline

BE Line Drainage 2 in centerline- Missed Wetland **MW 2002_G** is found within the proposed pipeline centerline. This concave basin had not been mapped by the company. It was a drainageway with 11.5 inches of soft soils. We could not verify that it met all wetland criteria. However these missed topographic drainages confound how the construction will alter hydrology.

Figure 21. Zakk at MW 2022_G standing on centerline.

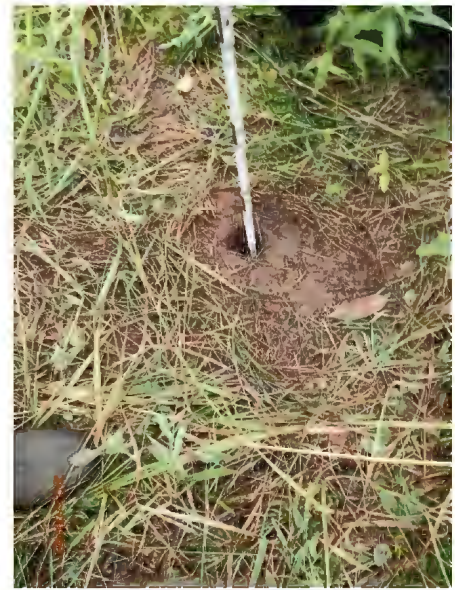
Figure 23 recent soil core at wirb039s_w

We had seen trucks parked from other environmental firms on Vogues Road and Casey Sag Road, on the east side of Tyler Forks River at the start of our field work, and noted 5 persons leaving as we were walking in. At this wetland (wirb039s_w) we noted a recent soil core ~27 inches deep that appears to be a soil sample close to the centerline (photo to right). A second area of disturbed soil was noted a bit later in the day approximately 20 feet north.

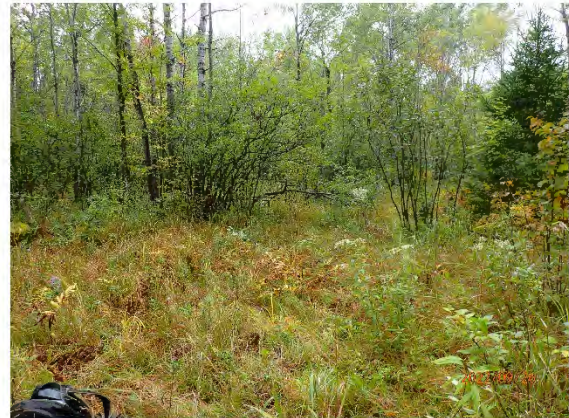
Figure 24 wirb039s_w

This wetland **wirb039s_w** is classified as a shrub dominated wetland by the company. The classification of forested would be more appropriate. We found a mosaic of forested, shrub, and sedge dominated wetland. The trees were immature forest with a shrub layer, varying from 50-60% tree cover. Shrub cover was estimated to be ~ 25% cover. Vegetation included *Populus tremuloides* (quacking aspen), *Acer rubrum* (red maple) and black ash in the overstory. Shrubs included winterberry and *Salix sp.* (willows), likely *Salix petiolaris* or slender leaved willow. The understory included *Carex crinita* (fringed sedge), blue green bullrush, *Doellingeria umbellata* (flat topped aster), woodland horsetail, *Geum macrophyllum* (large leaved avens), *Cleome glabra* (turtlehead), *Symphoricarpos puniceum* (purple stemmed aster), sensitive fern, *Pteridium aquilinum* (bracken fern), *Osmunda regalis* (royal fern), and *Osmunda claytoniana* (interrupted fern).

This wetland extends into the construction zone farther than mapped by the company. The wetland extended to the northeast (BE wetland 5) . Black ash was in the tree and shrub layer, otherwise, the vegetation was similar to that noted above in **wirb039s_w**. The concave basin had blackened leaves, with microtopography throughout, trees had shallow roots. Wetland soils were 11 inches deep.

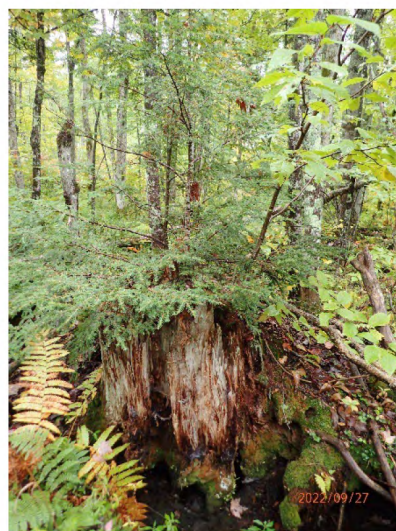
Figure 28 nurse log in wirc1019f

We reviewed **wirc1019f** that was delineated by the company and extends across and beyond the pipeline corridor. This wetland is proposed to be open cut and trenched. We meandered through the wetland. This forested wetland contained mature Northern white cedar and cedar saplings, showing active regeneration. Trees also included black ash, *Betula alleghaniensis* (yellow birch), *Tsuga canadensis* (Eastern hemlock) and red maple. The understory included Lady fern, ostrich fern, *Lycopus uniflorus* (Northern water-horehound), *Persicaria sagittate* (arrow leaved tear thumb) and a carpet of sphagnum moss. The wetland soils varied from 8 ½ to 38 to 56 inches in depth. There were blackened leaves and microtopography with shallow pools of water. The trees had shallow roots. The forest was recovering from past harvesting likely in the last century, however there were many good sized trees and areas that were mature and not harvested recently. The wetland forest overall was in good condition. Cutover stumps were moss covered, some acting as nurse log with hemlock and yellow birch as Figure 28 documents.

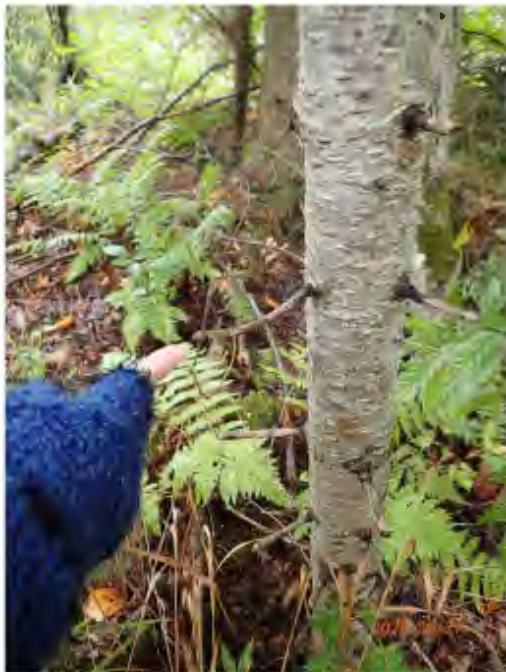
Figure 30 harvest of balsam fir evident

We also noted cut **aninaandag** or balsam fir boughs that are a cultural resource in the ceded territory. These appear to have been harvested (Figure 30).

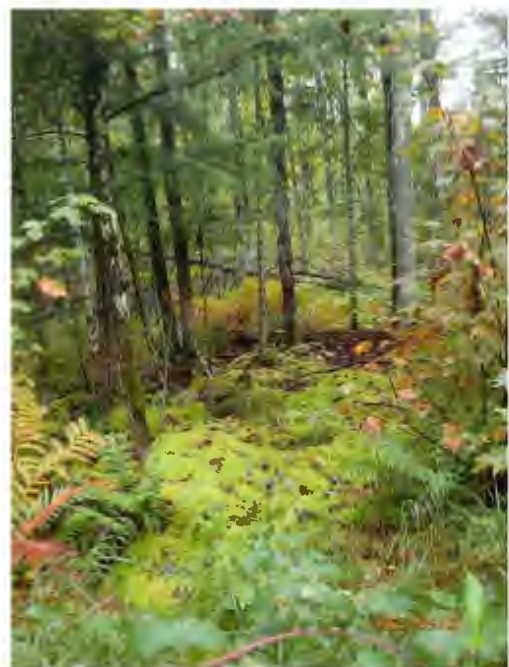
Figure 31 Sphagnum moss carpet in wirc1019f

As we meandered through this wetland there were lower areas with an inch of standing water (GLIFWIC mapped blue line on our maps). Vegetation included cattail, and *Iris versicolor* (blue flag). Slightly higher ground had carpets of club mosses (*Lycopodium sp.*) and *Gaultheria procumbens* (wintergreen).

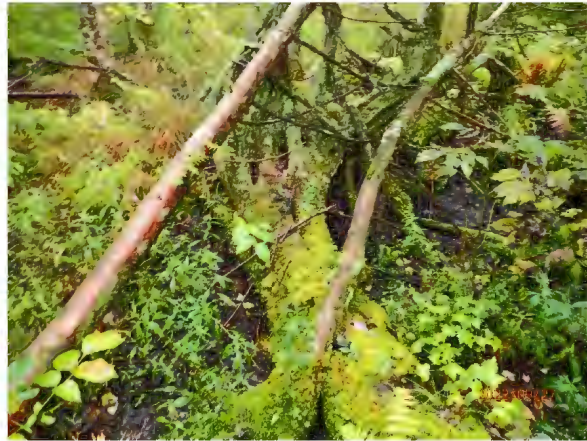
Figure 32. Microtopography and downed logs provide critical habitat in wirc1019f.

Multiple wetlands in the vicinity of Tyler Forks provide moist rotting logs, and rocks that provide appropriate habitat for the Eastern red-backed salamander. *The proposed pipeline construction will destroy and displace the forest logs and microtopography that harbor amphibians.*

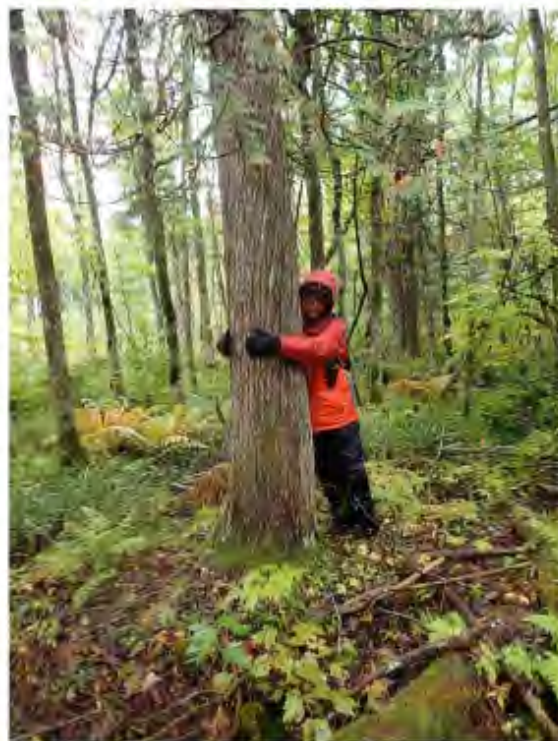
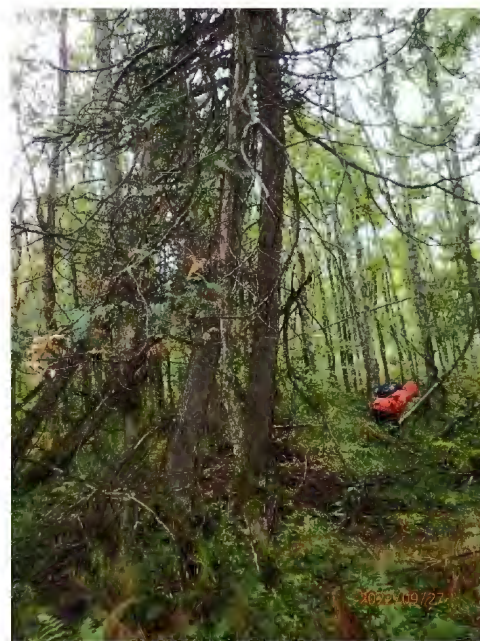
The forested wetland (wirc1019f) continued with areas of mature northern white cedar (Figures 34 & 35 below). Eight large mature cedars were counted in one area. Large logs provide shelter and the red-backed salamander was present. The depth of wetland soil was 56 inches in this area.

Figure 34. mature white cedar in wirc1019f with Dawn White

Figure 35. Mature white cedar in wirc1019f

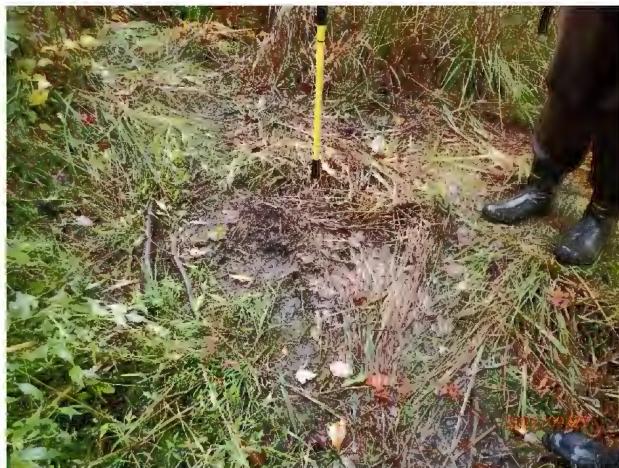
Figure 36. recent soil bore in wirc1019f.

We found another area of recently disturbed soil on the southeast border of the wetland within the proposed construction corridor.

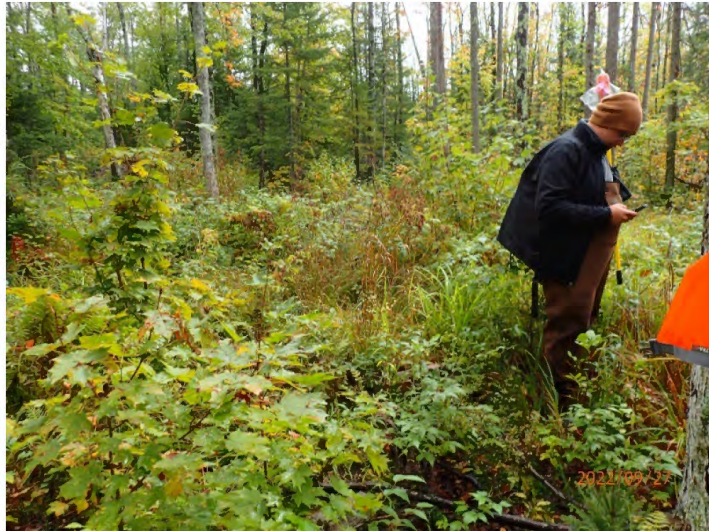
Figure 40. Zakk at possible MW 2022_M

We noted another missed wetland **MW 2022_M** (BE J) just on or close to the survey corridor southeast of Wirc1022f. It had microtopography with low points and supported wetland vegetation including woolgrass. This is also close to the large mapped WDNR wetland surrounding the corridor.

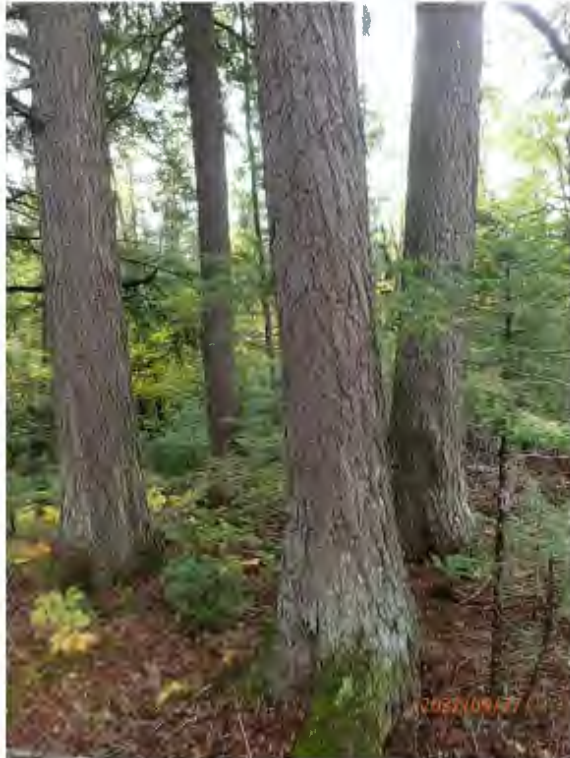
Figure 43. Mature old growth hemlock in uplands as buffer to extensive wetland complex

Walking south we encountered an upland mature old growth forest of massive northern white cedar and hemlock trees that is due north of wetland **wird013f**. The Eastern hemlock or **gaagaagimizh** are shade tolerant, slow growing and long lived (up to 600 years). Although these trees are not protected in uplands, they provide important ecosystem services to the adjoining wetland slowing down water flow and harboring wildlife. **Gaagaagimizh** has cultural importance as a traditional medicine. These old trees are in the centerline of the pipeline disturbance. Although there is evidence of forestry harvest in uplands to the north, the upland buffer to this large wetland has not been disturbed. This buffer is unreported by the company, despite being on the proposed centerline.

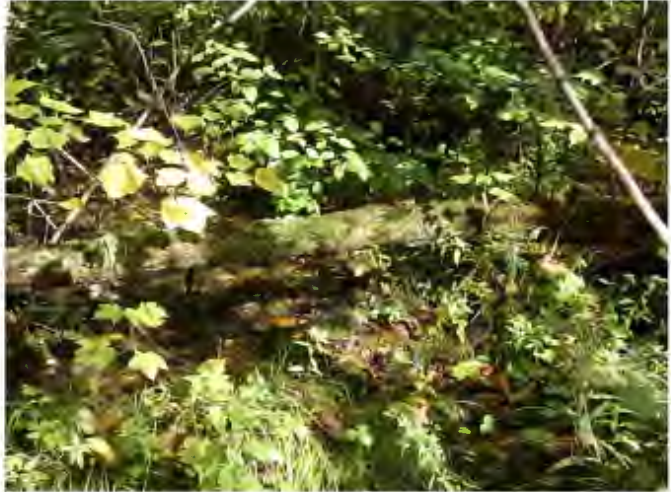
Figure 48. Standing and flowing water in wirc013f_x

The wetland soils measured were 16 inches in depth. There were downed logs covered in moss and lichen, and pools of water creating micro habitats within. Hydrology included pools of standing water ranging from an inch to several inches in depth, saturated soils to the surface, water stained leaves and microtopography. We also found a stream of water actively flowing across the prospective work space. This was in a fairly dry time of year.

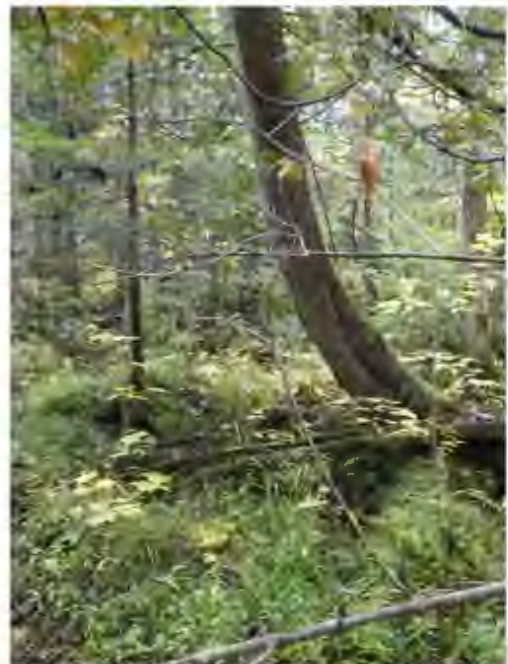
Figure 49. mature white cedars in wirc013F_x.

The wetland appears to have had little historical disturbance. The overstory included Northern white cedar, Eastern hemlock, red maple, and *Acer spicatum* (mountain maple). All age class of trees were present including northern white cedar seedlings. The understory included sedges, Brome hummock sedge, dwarf red raspberry, *Chrysosplenium americanum* (American golden saxifrage), sensitive fern, false nettle, *Cicuta bulbifera* (bulblet-bearing water hemlock) and multiple orchids past bloom. The possible identification is a *Platanthera* sp green bog-orchid however there are difficulties identifying to the species level according to Risen (Risen, Orchids of the North Woods 2010). We counted eight *Platanthera* sp. in one area. The company delineation notes a different orchid present: *Corallorhiza trifida* or early coralroot (page 5251 of Application Attachment C1_2020 data). Based on this there are at least two orchid species present.

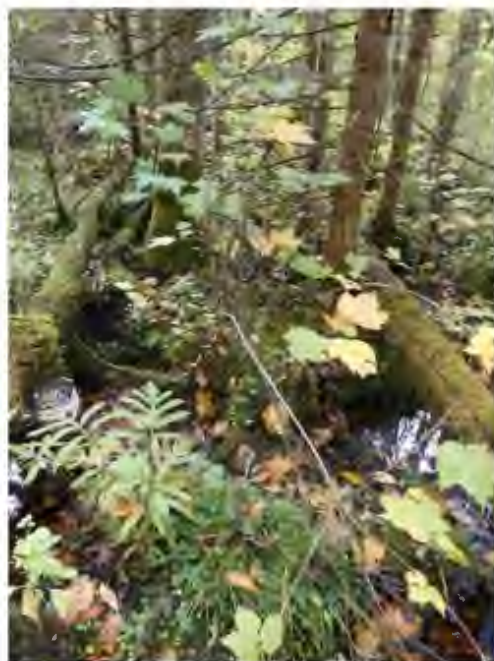
Figure 50. Water rich swamp in wirc013f_x.

The wetland was of high habitat value, high wildlife value, and high aesthetic value. It is also so rich in water, seeps and small streams that the prospect of an open trench to install the pipeline will create a construction nightmare.

It is painful to imagine how this wetland forest would fare after tree and log removal, vegetation removal, trenching with spoil banks, dewatering a trench that would continuously fill with water, transport of sediment laden trench water to other parts of the wetland, compression of muck and soft soils with timber mats and heavy equipment, equipment rutting, eventually replacing the trench and leveling out all microtopography and altering hydrology. The construction will cause irreparable harm to this wetland system, and cause the death of trees, seedlings, vegetation and amphibians among others.
