October 5, 2023

**ADDENDUM TO REVIEW OF ENBRIDGE LINE 5 WISCONSIN SEGMENT RELOCATION PROJECT-B**

**FIELD REVIEWS July 10-13, 2023**

**Preliminary Report**

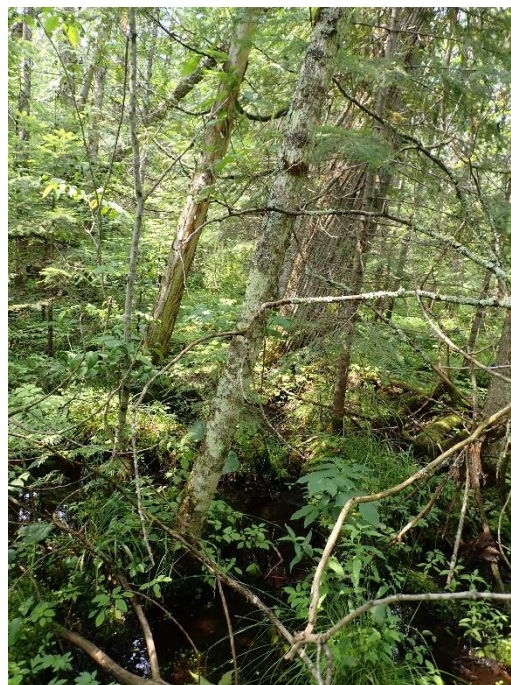
Figure 3. Northern wet-mesic forest in wirc013f\_x.

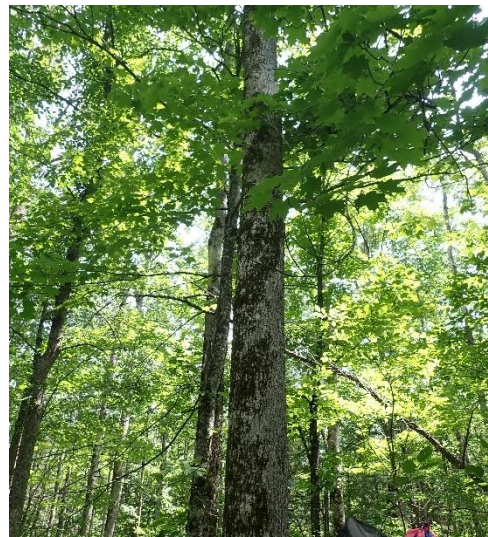
Figure 4. Black ash suitable for cultural uses with Dawn White in mature black ash swamp (wirc028f- south.

Wetland **wirc028f** has areas of immature Northern Hardwood Swamp, mostly dominated in the overstory by more immature trees. However, the understory in all areas of immature swamp was diverse and native. The southern portion of wirc028f, as described below, is **mature black ash swamp**. The trees were very large and mature, the soils were mucky and saturated, and the understory very diverse and well-developed including orchids.

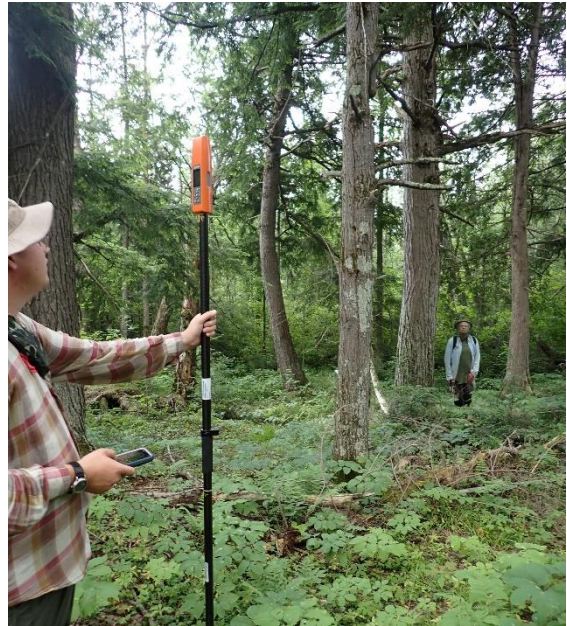
As reported in the 2022 field work, Wetland **wirc013f\_x**, the wetland system south of Vogues Road, and north of Tyler Forks is a stunning wetland with at least two orchid species, and a plethora of native trees, shrubs and forbs including mature northern white cedar, and mature black ash. The habitat had pools of standing water and a running rivulets of water that do not appear on the company maps. Because this wetland is proposed for open trenching, along with many other forested wetlands in this project, there is high risk of decades or more of damage to the structure, functions and wildlife that inhabit this wetland, both within the immediate construction corridor and outside of it. The upland buffer on the north side of this wetland has mature, old growth northern white cedar and old growth Eastern hemlock.

Figure 3. Old growth Northern white cedar and Eastern hemlock on **wirc013f\_x** upland buffer. Zakk in foreground standing on centerline, Steve in background on centerline.

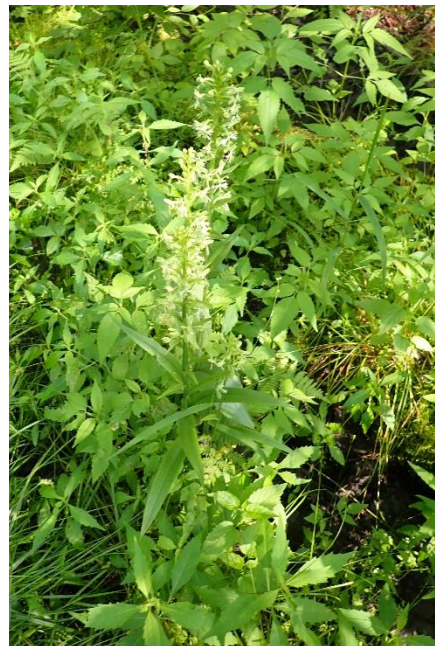
In 2023 we found a multiple blooming *Platanthera lacera* (ragged fringed orchid) in the wetland wirc 019f to the north. However the orchids in wetland wirc013f were too early to identify to species level, but appeared to be *Platanthera* sp. Adding to the above list are: *Iris versicolor* (blue flag), *Trillium cernuum* (nodding trillium), *Caltha palustris* (marsh marigold), *Micranthes pensylvanica* (swamp saxifrage), *Callitriche* sp. (water starwort), *Gaultheria hispidula* (creeping snowberry-bog wintergreen), *Moneses uniflora* (one sided pyrola), *Pyrola elliptica* (elliptic shinleaf), *Osmunda cinnamomea* (Cinnamon fern), *Impatiens capensis* (jewelweed), *Mitella nuda* (Naked Miterwort), *Ranunculus hispidus* (hispid buttercup), *Aralia nudicaulis* (wild sarasparilla), *Viburnum opulus* (high bush cranberry), *Acer spicatum* (mountain maple) seedlings, northern white cedar seedlings, hemlock seedlings. We counted over 20 *Platanthera* sp. orchids in one area. There were abundant mosses and lichens including staghorn lichen.

Figure 4. *Platanthera lacera* in wirc019f.

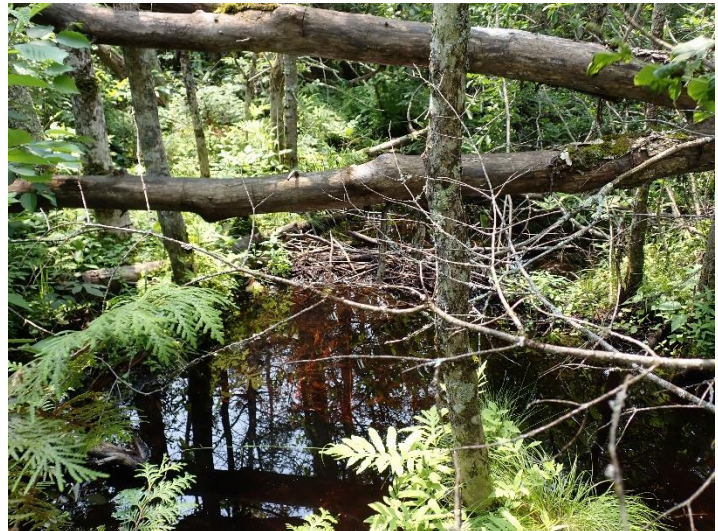
The wetland had a high degree of microtopography, with downed logs, hummocks and pools. There was hydrologic diversity from saturated mucky soils, to standing water in pools, to flowing streams of water. There were a number of surface (standing) water depths recorded that varied from 3-12 inches (3, 4, 5, 6, 7, 8, 12). A small beaver dam backed up more water in an area. Groundwater signatures besides actively flowing water included plants: marsh marigold, swamp saxifrage, and groundwater-stained flocculant matter in the stream. We videoed multiple streamlets actively flowing to the west and south across the proposed pipeline workspace. This is in a period of moderate drought. At one area we calculated there was 70% standing or flowing water surrounding us.

With our rebar we measured a variety of soft soils or fines in the pools, varying from 9", 20", 24" and 49". Our rebar often hit rock.

Figure 6. standing water and microtopography in wirc013f.

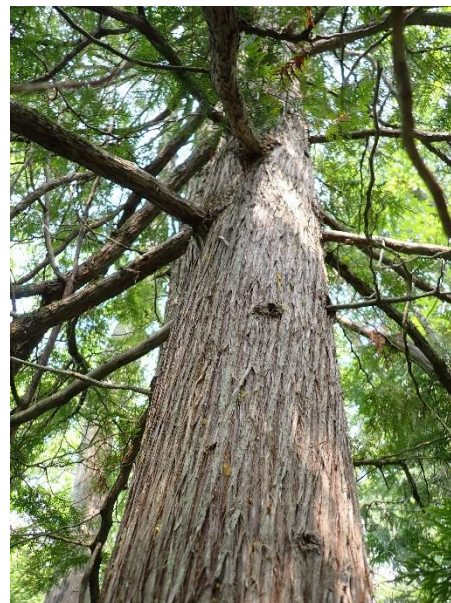
Figure 9. mature northern white cedar in wirc013f.

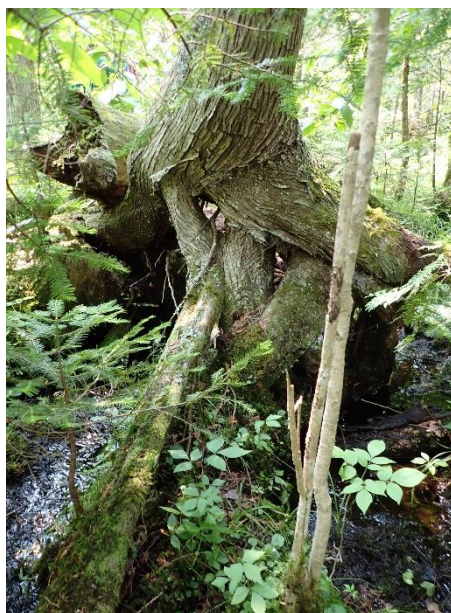
Figure 10. Complicated microtopography and wet mucky soils in wirc013f.

The construction of this portion of the pipeline is proposed to be open cut. The destruction of the cedar swamp will be compounded by the decision to open cut it. To reiterate from the 2022 report: “It is painful to imagine how this wetland forest would fare after tree and log removal, vegetation removal, trenching with spoil banks, dewatering a trench that would continuously fill with water, transport of sediment laden trench water to other parts of the wetland, compression of muck and soft soils with timber mats and heavy equipment, equipment rutting, eventually replacing the trench and leveling out all microtopography and altering hydrology. The construction will cause irreparable harm to this wetland system, and cause the death of trees, seedlings, vegetation and amphibians among others. Habitat suitable for rare species including rare mammals will be lost, and the corridor will create route for invasive species” (Thompson, 2022 report).

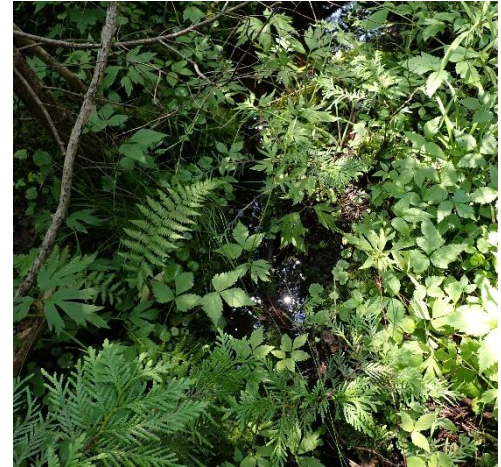
This reserve of mature northern white cedar and seedlings is at risk from immediate removal of mature trees, and their seedlings/saplings. The secondary impact is that once the site is leveled for the pipeline installation, all microtopographic hummocks, logs and safe places for seeds to develop are erased, and with pipeline maintenance will continue to be void. This will include to all cleared workspace left level, which- even if not disturbed will not be conducive to seedlings. Finally the third impact is that the open corridor invites white tailed deer to enter the forest and browse along the open corridor and adjacent areas, favoring cedar.

Figure 13. Northern white cedar seedlings throughout wirc013f-north.

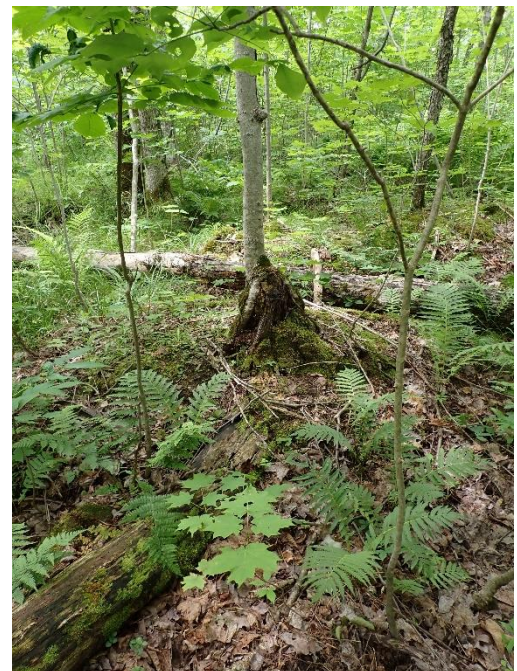
**Wirc013f- South** This wetland is so large that we could not field review it entirely from the northern access. We returned to the wetland from the south on July 12, 2023 and entered from the east primarily along a forest access road, staying within public land, in order to better understand the entire wetland community. This was a very confusing area as the wetland community was completely different from the Wirc013f community accessed from the north which we have investigated in both 2022 and two days previous this year. Someplace between the last area we observed and collected data on July 10, 2023 and the wetland boundary on the south end - the wetland community type changed from Northern wet-mesic forest to a much drier albeit forested community. The vegetation, hydrology and structure changed from the mucky, seepy log strewn water rich wetland to what looks more like a wetland/upland mosaic.

Figure 14. south end of wirc013f is much drier and the area was confusing considering it was lumped into the same plant community on most company documents as the northern portion of wirc013f.

This area is very confusing and appears to be data poor. The lumping of this more wetland/upland complex in with the northern conifer dominated areas to the north is concerning as these areas have different functional values. The values are degraded when mixed. Construction impacts are also different. However, what is consistent between the north and south of this delineated wetland is that there are very old trees present- very possibly old growth forest- in this portion of the proposed pipeline route which are not considered as an impact in the company's assessments of functional loss.

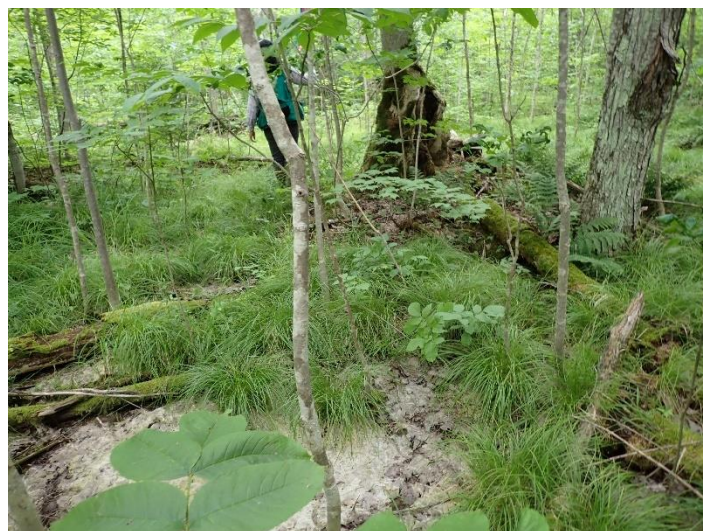
This wetland community is Northern Hardwood Swamp dominated by black ash. The black ash were in mixed aged classes and we measured several mature trees with circumferences of 47 inches and 50 inches. A yellow birch had a circumference of 96 inches, and is directly within the permanent clear zone over the proposed pipeline.

Figure 11. wirc025f black ash swamp.

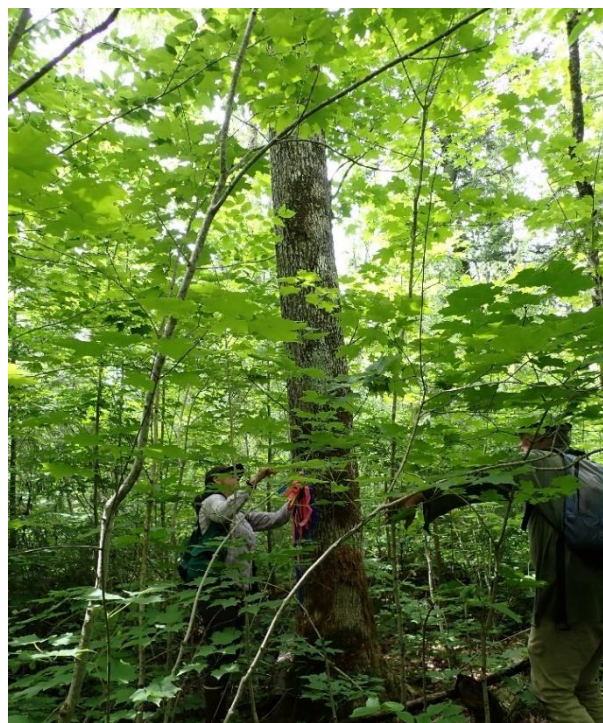
These Black ash are culturally important to the Ojibwe; Dawn White found a straight tree that had a straight trunk suitable for cultural uses (Figure 12).

Figure 12. Black ash suitable for cultural purposes with Dawn White in wirc025f.

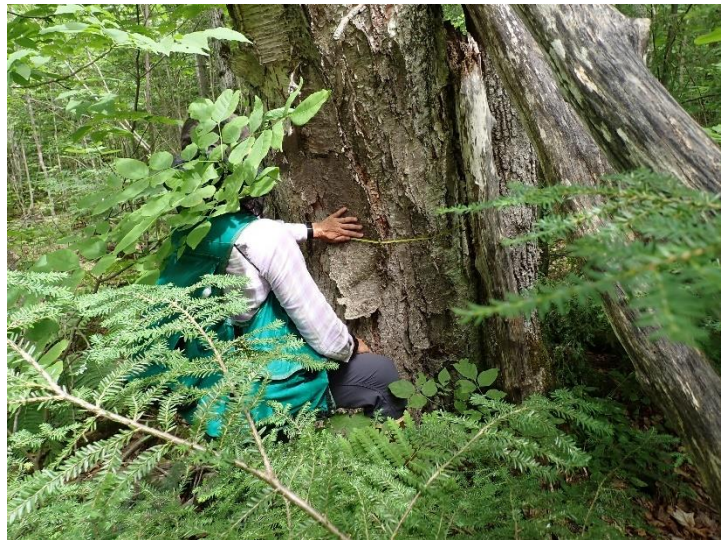
The impacts to this portion of the pipeline route include the removal of some very large mature trees including Eastern hemlock, Yellow birch and Black ash. This entire area- from the upland Eastern hemlocks and Northern white cedars on the north end of wirc013f\_x, the mature Northern white cedar in the cedar swamp or wirc013f, and the wetland and upland mature trees on the south end of wirc013f\_x as well as the black ash in wirc025f are mature and many could be considered old growth. Mesic “Old-growth forest is now extremely rare in Wisconsin, comprising at best only a few one-hundredths of 1% of forest cover (Frelich 1995)” WDNR, 2015. As discussed in the 2022 field work report, the Eastern hemlock or **gaagaagimizh** are shade tolerant, slow growing and long lived (up to 600-800 years). They provide important ecosystem services and **Gaagaagimizh** has cultural importance as a traditional medicine. In the uplands they slow water, buffer the wetland and harbor wildlife. They provide critical wildlife cover and forage in winter, and nest sites and food sources in summer for songbirds.

Figure 13. Old growth yellow birch with a circumference of 96 inches.

There appears to be no recognition of the permanent loss of these mature – old growth trees in this wetland and others in the company reported impacts. These will not grow back to this stature in our lifetime.

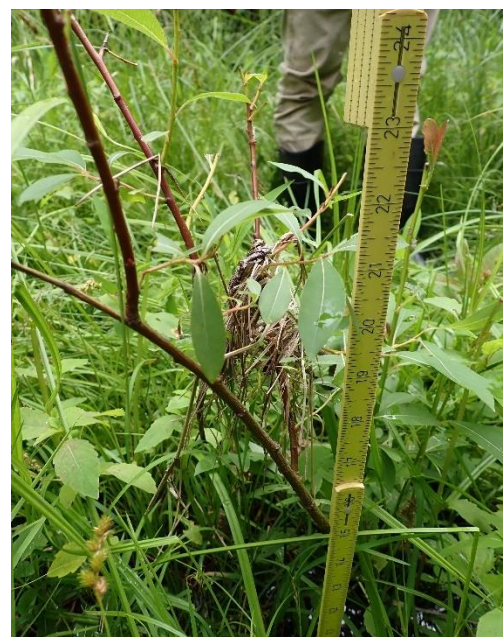
Figure 14. Drift lines at 21 " above ground in wirc019f in the trail.

**Wirc 019f** was reviewed. The access road bisects a large, forested swamp and is currently unmown<sup>2</sup> and very wet with wetland vegetation. There were northern white cedar on both sides of the access road. Groundwater flock was visible on the west side of the road. There were drift lines to 21 inches high in the wetland on the access road. Vegetation included woolgrass, cattail and arrowhead. This area will be impacted by the use of the access road for the proposed project. The modifications in order to allow for heavy equipment will fill wetland, based on the current conditions. The impact to adjacent forested wetland areas will include sedimentation, and invasive species.

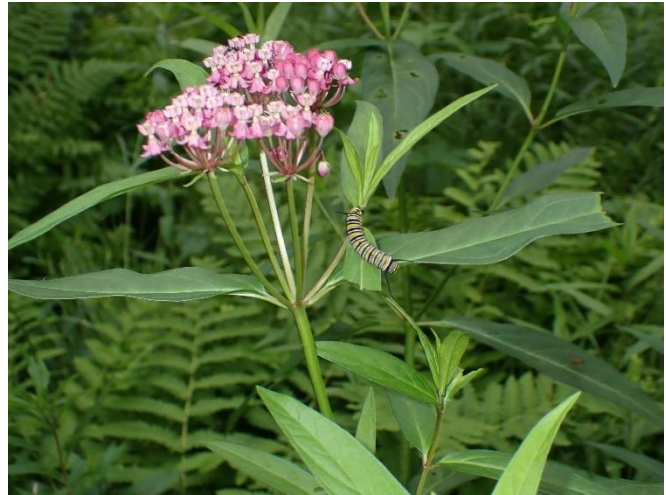
Figure 15. Swamp milkweed and monarch caterpillar in wirc046e.

**Wirc046e** was field reviewed. We found *Asclepias incarnata* (swamp milkweed) with five monarch caterpillars on them. Eggs were found as well on Milkweed leaves.

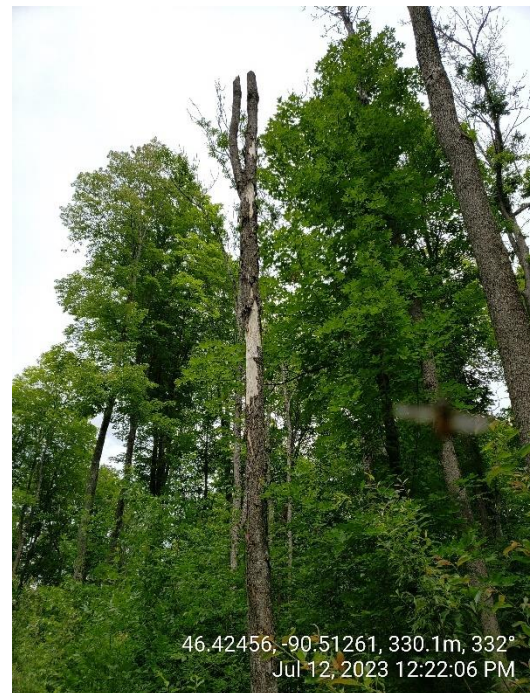
**Wirc20e** was field reviewed. A tree that could harbor bats was found.

Figure 16. Peeling bark suitable for bat use. Jessica Strand photo.

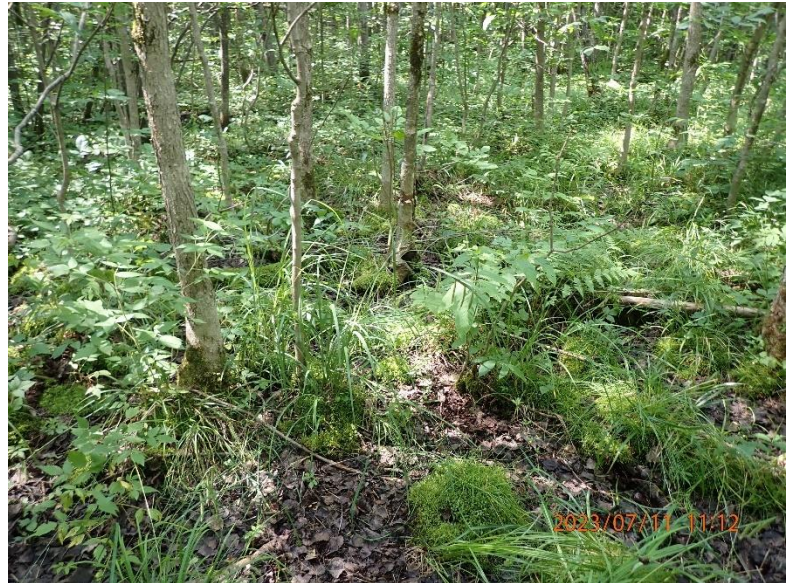
The wetland canopy was *Populus tremuloides* (quaking aspen), *Abies balsamea* (balsam fir), *Fraxinus pennsylvanica* (green ash), *Fraxinus americana* (white ash) and *Fraxinus nigra* (black ash). The shrub layer included *Ilex verticillata* (common winterberry) and *Corylus americana* (American hazelnut).

Figure 17. wirc028f- north of 2 track access- immature hardwood swamp

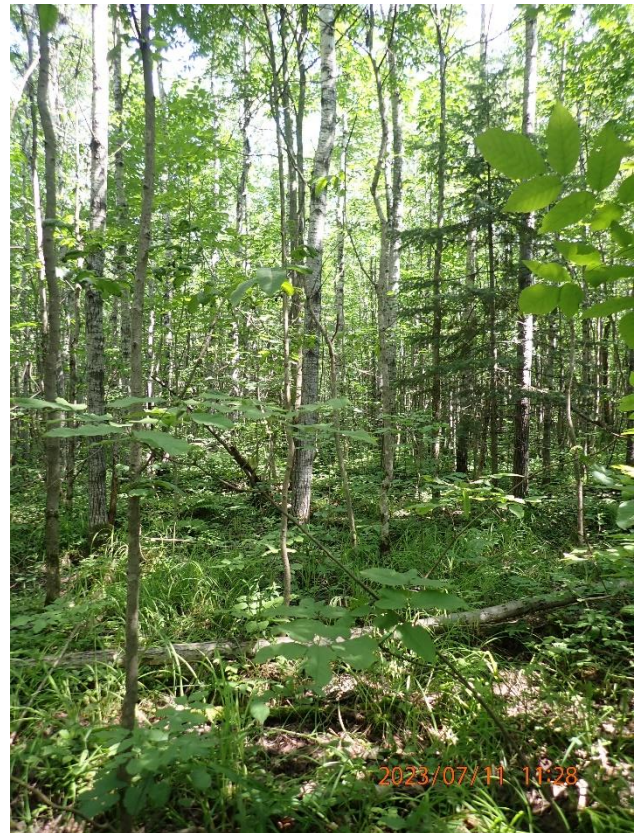
The wetland canopy was *Populus tremuloides* (quaking aspen), *Acer rubrum* (red maple), *Fraxinus pennsylvanica* (green ash), *Tilia americana* (basswood) and *Fraxinus americana* (white ash). The shrub layer included *Fraxinus pennsylvanica* (green ash), *Ilex verticillata* (common winterberry) and *Lonicera canadensis* (American fly-honeysuckle). Herbaceous layer included *Carex criniata*, *Carex projecta*, *Agrostis perennans* (upland bent grass), *Athyrium filix-femina* (Lady fern), *Dryopteris intermedia*, (glandular wood fern), *Geum canadense* (white avens), *Ranunculus acris* (tall buttercup), *Pyrola elliptica* (shinleaf), *Agrimonia striata* (roadside agrimony), *Equisetum sylvanicum* (woodland horsetail), *Ribes triste* (swamp red current), and *Rubus pubescens* (dwarf red raspberry).

Figure 19. wirc046f, immature hardwood swamp with diverse understory.

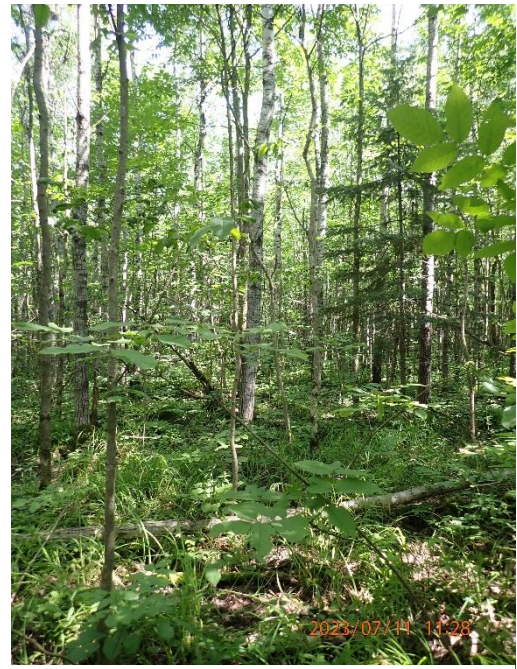
The wetland canopy was *Populus tremuloides* (quaking aspen), *Abies balsamea* (balsam fir), *Fraxinus pennsylvanica* (green ash), and *Acer rubra* (red maple). The shrub layer included *Ilex verticillata* (common winterberry), *Viburnum lentego* (nannyberry) and green ash saplings. Herbaceous layer included *Carex crinata*, *Carex gynandra*, *Equisetum sylvanicum* (woodland horsetail), *Equisetum arvense* (horsetail), *Maianthemum canadensis* (Canada mayflower), *Athyrium filix-femina* (Lady fern), *Dryopteris carthusiana* (spinulose woodfern), *Osmunda claytoniana* (interrupted fern), *Ranunculus recurvatus* (hooked buttercup), *Onoclea sensibilis* (sensitive fern), *Mitchella repens* (partridge berry),

Figure 20. wird028f- south of 2 track- immature hardwood swamp

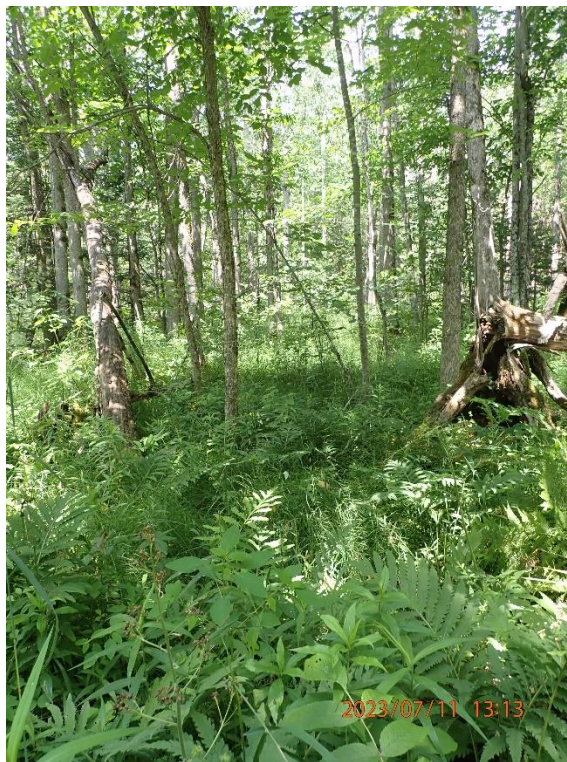
South of the previous description (in the same wetland) the vegetation became much more mature. The following is the description (on the centerline of the proposed pipeline) of the **mature Northern Hardwood Swamp, Black Ash Swamp**. The black ash had mixed age classes with some very large black ash. One tree had a circumference of 56 inches. The soils were muck with a number of groundwater indicator plant species including swamp saxifrage, marsh marigold and American golden saxifrage. There were several northern white cedar. The understory was native, and diverse including orchids. This is a very good example of an intact native black ash swamp.

Figure 21. wirc028f- south, mature Northern hardwood swamp, black ash swamp.

Hydrology included soils saturated to the surface, muck on the surface, buttressing/shallow roots, and concave basins. Water would well up as we stepped on the mucky soil. Soils were 4-22 inches deep, with rock below.

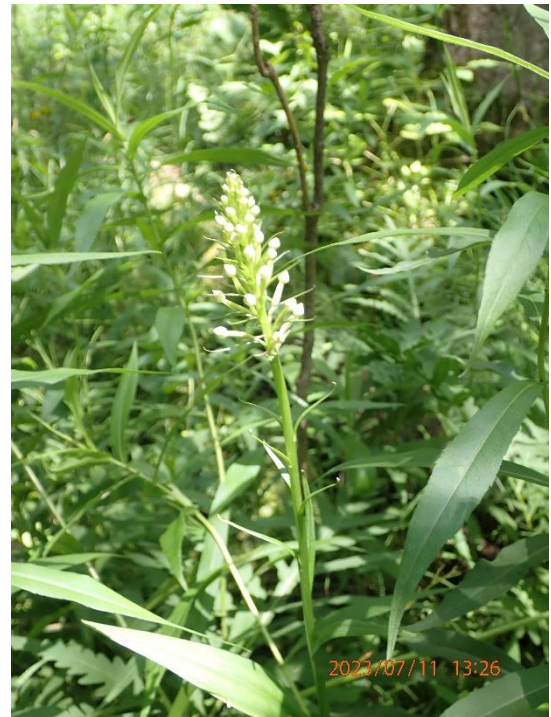
On our way north retracing this wetland we found orchids not yet in bloom. We identified them to the *Platanthera* sp. group. There were at least three orchids close together. We also found *Cirsium muticum* or marsh thistle. We also found five large northern white cedars west of the pipeline but within the workspace.

Figure 22. *Platanthera* sp. orchid in wirc028f- south

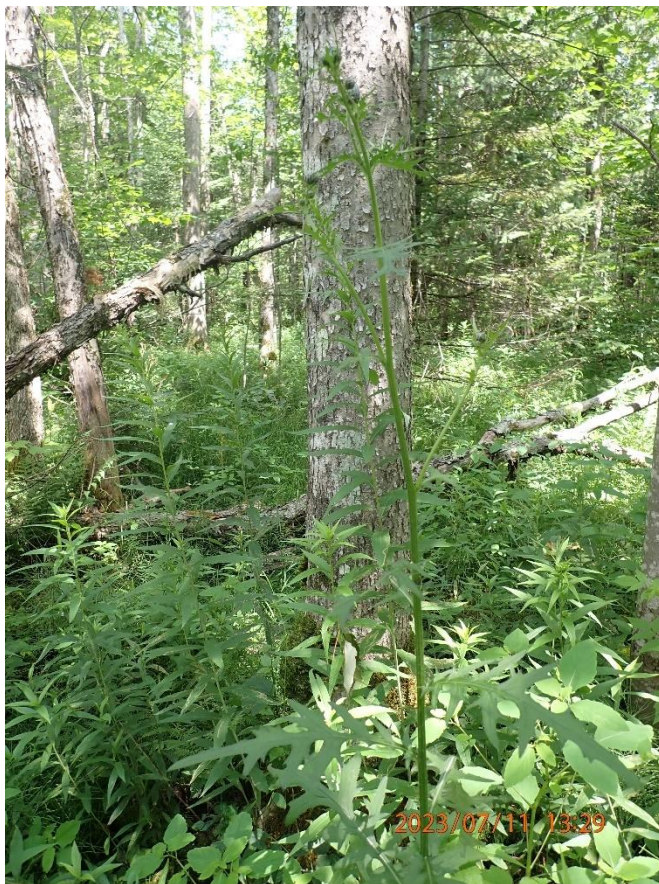
Figure 23. wirc028f- *Cirsium muticum*- swamp thistle.

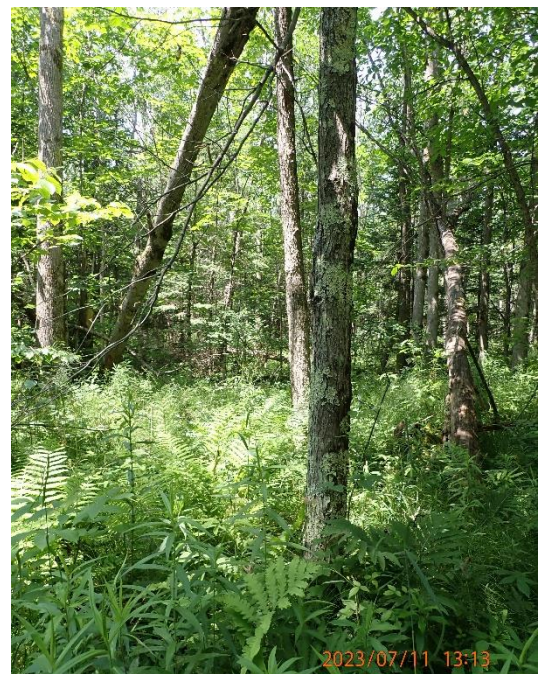
Figure 24. wirc028f- black ash and diverse native understory
