Re: WDNR Water Resources Application for Project Permits Navigability Determination

Navigability Determination

Enbridge Feature I.D.: WDH-102 x1, WDH-102 x2, and WDH-102 x3

Enbridge Feature I.D.: WDH-107_x1 and WDH-107_x2

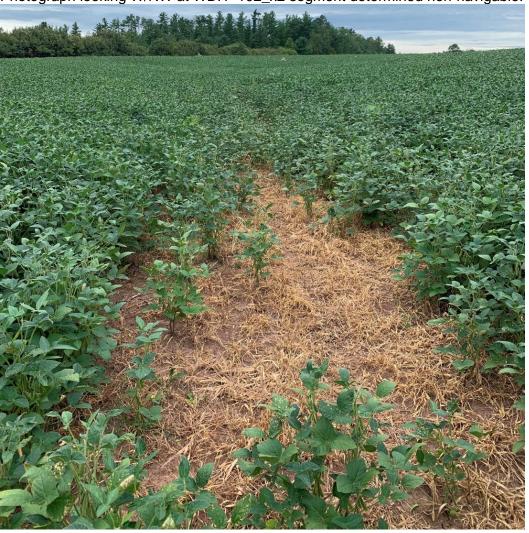
The DNR field review completed on August 27th evaluated the features for navigability determination. The DNR determined that segments of the feature were not navigable (WDH-102_x1 and WDH-102_x2) and segments of the feature were navigable (WDH-102_x3) (see figure 1).

Photograph looking W/NW at WDH -102_x2 segment determined non-navigable.

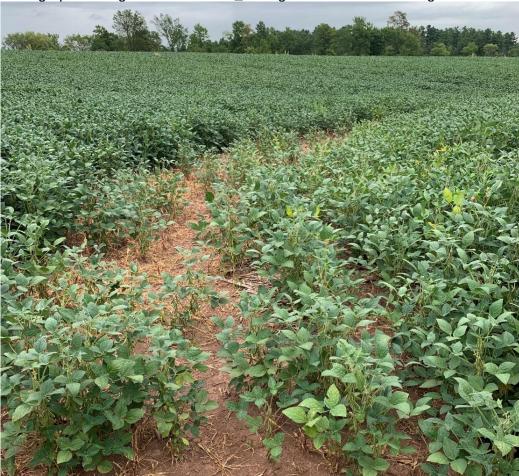
Photograph looking SE at WDH-102_x3 segment determined navigable.

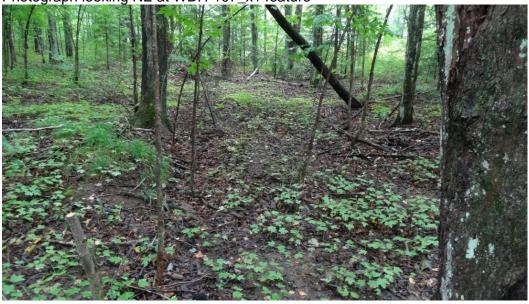
The DNR field review on August 27th evaluated the feature segments for navigability determination. The DNR determined that the feature segments were not navigable (WDH-107_x1 and WDH-107_x2).

Photograph looking NE at WDH-107_x1 feature

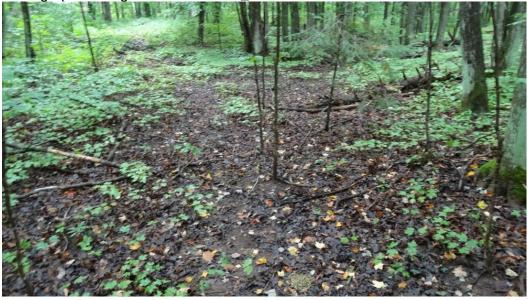
Photograph looking SW at WDH-107_x1 feature

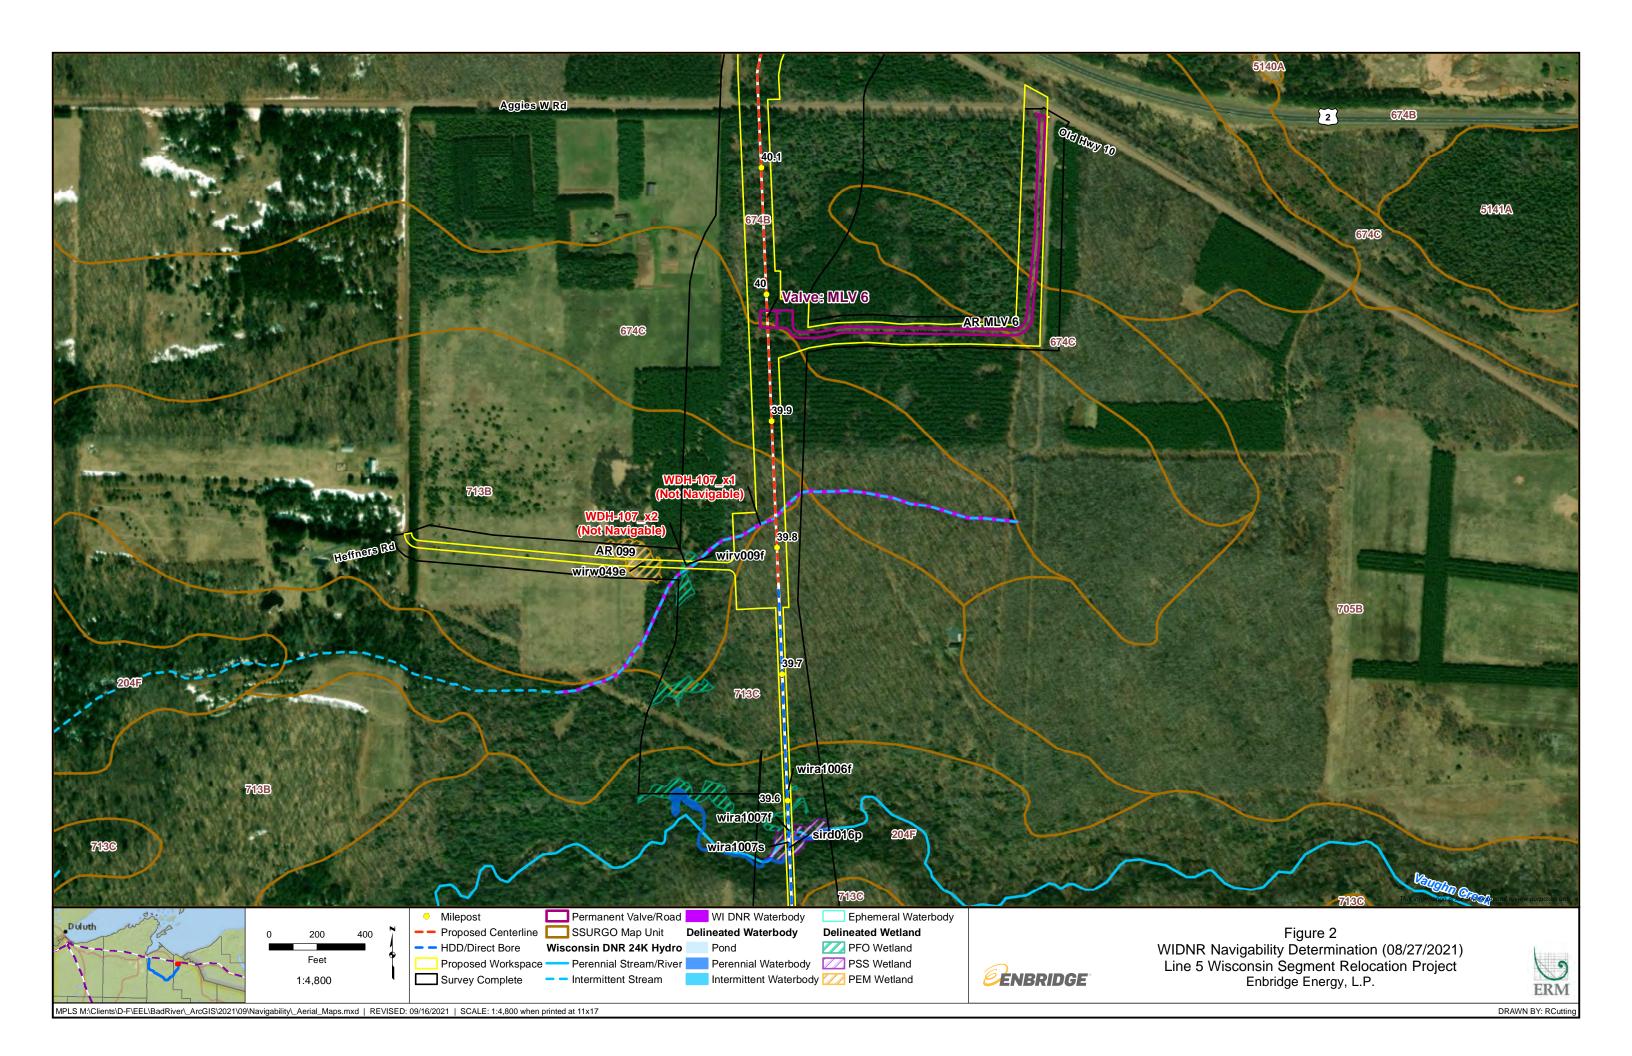
DNR 24K Hydrography data identifies this feature as Unnamed Waterbody (WBIC 5001801). The area was reviewed by Enbridge field crews in 2019 (see figure 2). Enbridge's field delineations evaluated the locations and determined that the feature did not meet the definition of a waterbody, as discussed above (identified as noirv003). However, WDH-107_x2 was identified as a wetland (wirv009f).
