Flood Study Sugar River Model, USH18/151 to White Crossing Road

Town and City of Verona, WI;
Dane County, WI

July 17, 2024

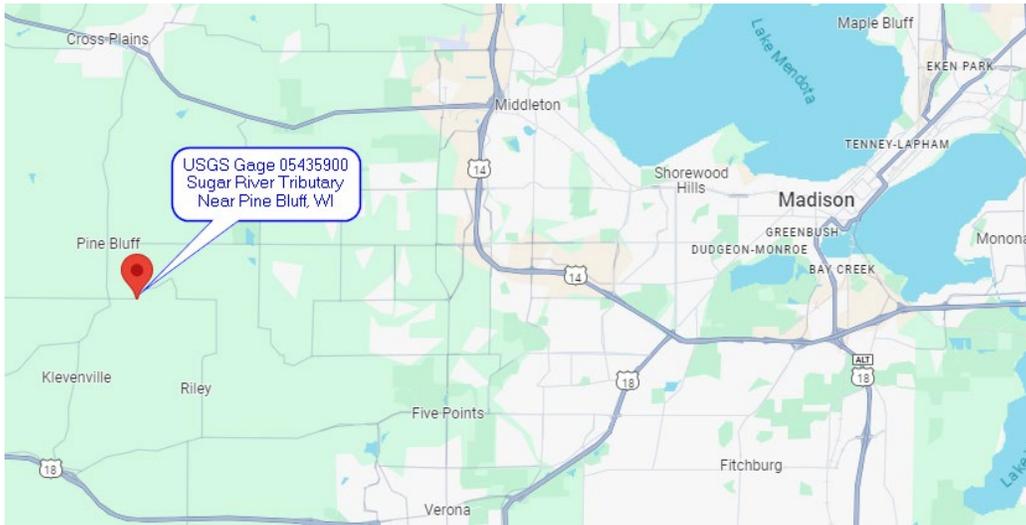
Figure 2. Streamgage Location

The 46.6 square mile watershed is broken into multiple sub watersheds in the effective HEC-HMS model (Figure 3). The HEC-HMS model was calibrated to a streamgage in the watershed, #5435900 (located at Sugar River Tributary Near Pine Bluff, WI) as seen in Figure 2. This gage is located at the confluence of subbasins R120W120 and R110W110 (Figure 3). The 2003 100-year flow at the gage was measured to be 850 cfs. To calibrate to this value, the CNs for all basins in the model were reduced to 55.

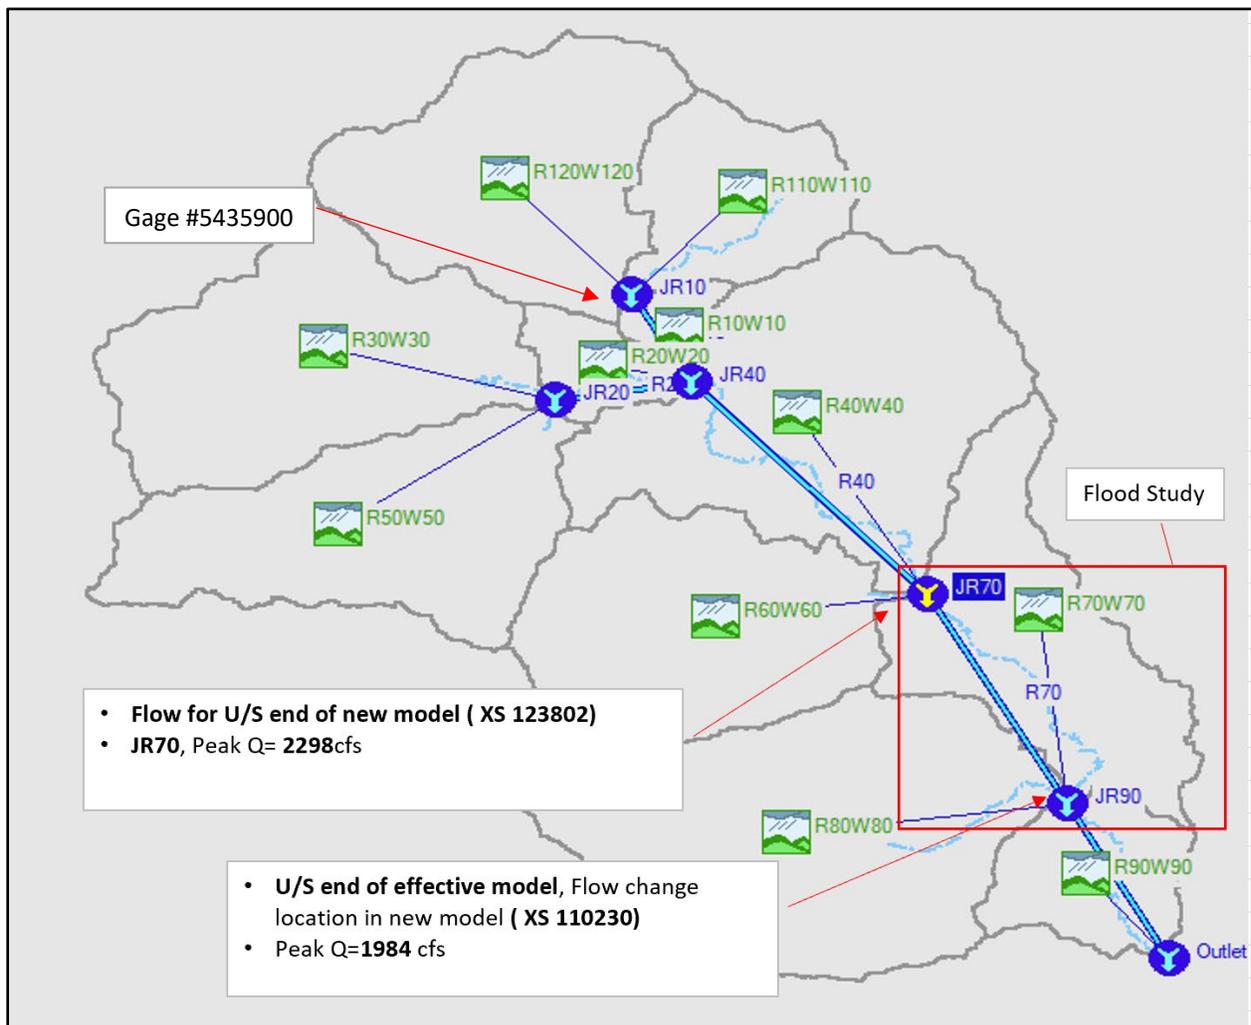
Figure 3. HEC-HMS model watershed (46.6 square miles) and location of 100-year flows applied in HEC-RAS model

Based on the effective HEC-HMS model, two flow change locations were added to the Existing Conditions HEC-RAS model (Figure 3):

1. At the upstream end of the Existing Conditions HEC-RAS model (cross section 123802), the 100-year flow of 2,298 cfs is applied, equal to the flow value at Junction JR70 in the HMS model. This is the confluence of the Sugar River with subbasin R60W60 in the HMS model.
2. At cross section 110230 (just downstream of the USH 18/151 bridge), the 100-year flow of 1,984 cfs is applied, equal to the flow value just upstream of the confluence of JR90 (the confluence of the Sugar River with subbasin R80W80). 1,984 cfs is also the flow applied at the upstream boundary in the effective model of the Sugar River downstream of USH 18/151.

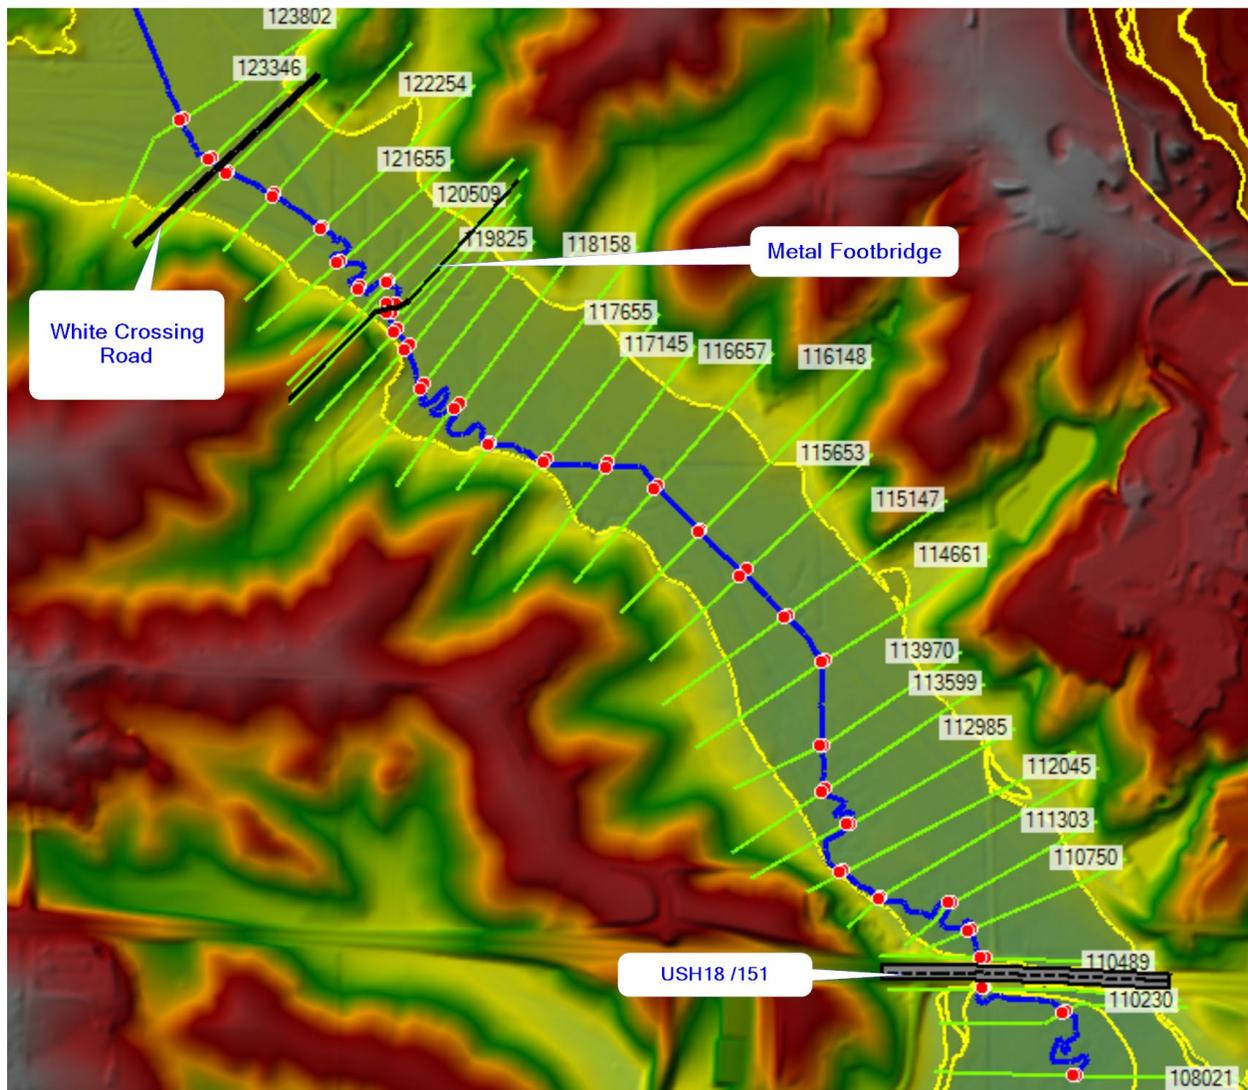
Figure 4. Existing Conditions model cross sections

The Existing Conditions model extents span 800 feet downstream of U.S. Highway (USH) 18/151 to just upstream of White Crossing at a confluence between the Sugar River and an Unnamed Tributary, a total reach length of approximately two miles (Figure 4). The most upstream cross section is 123802. The downstream end of the Existing Conditions model ties into cross section 108021 of the downstream effective hydraulic model. This section is also the FEMA lettered cross section CE shown in Figure 5. This location was selected as a tie-in between the models because it allows for appropriate hydraulic modeling of the USH18/151 crossing. In the downstream effective model, USH 18/151 crossing was outside the limits of study and therefore was not previously modeled.

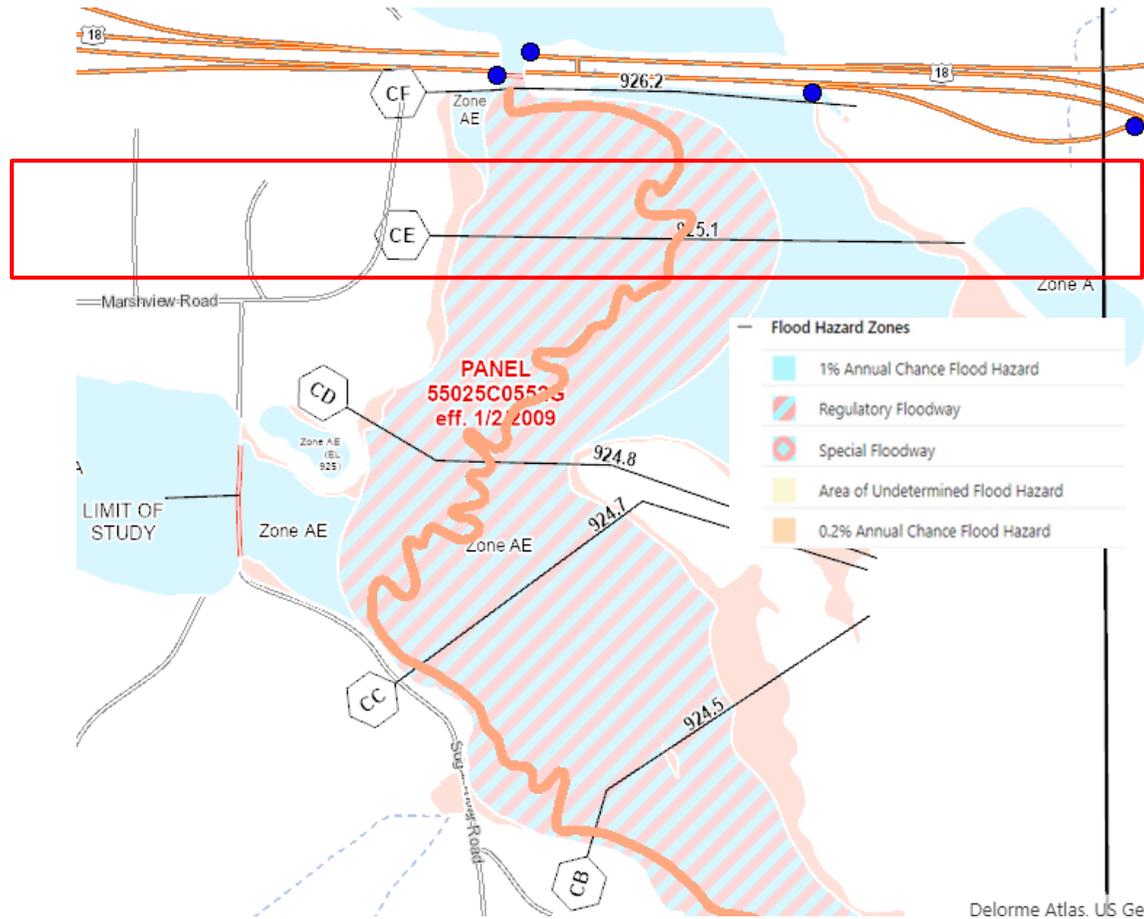
Figure 5. Location of Existing Conditions downstream model boundary

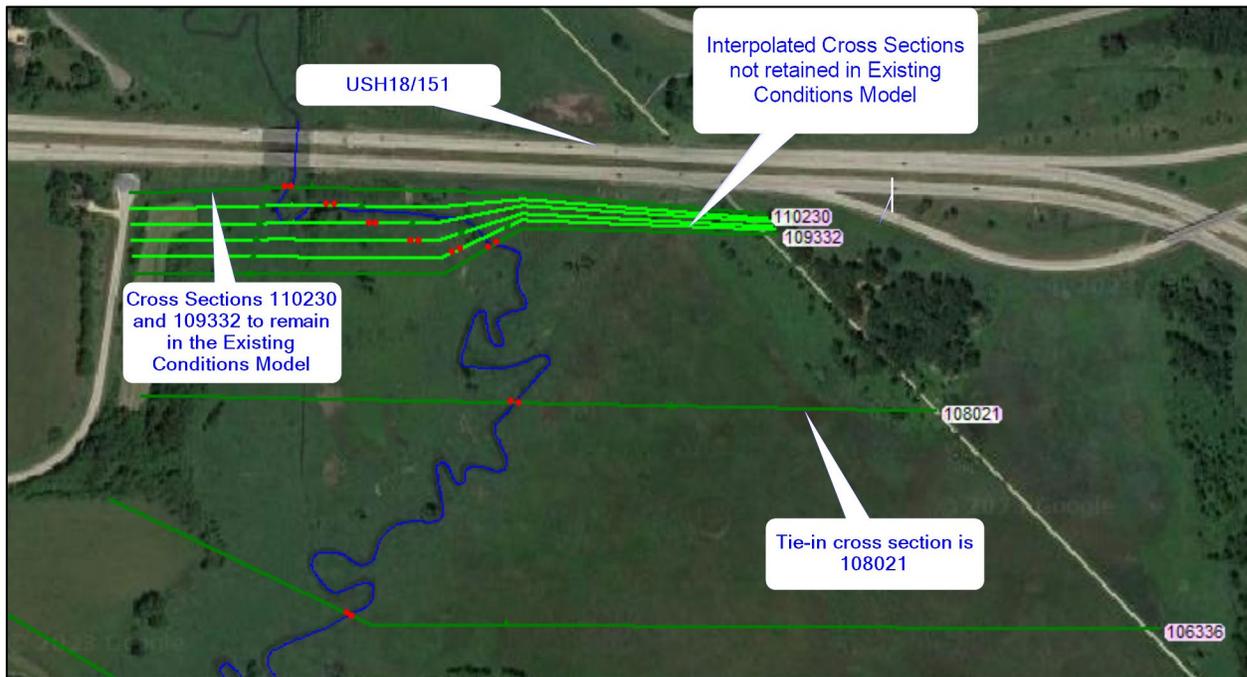
Figure 6. Tie-in cross sections with downstream effective hydraulic model

Upstream of cross section 108021 in the downstream effective model are four interpolated cross sections and two non-interpolated cross sections (Figure 6). New survey data was collected for the two non-interpolated cross sections (110230 and 109332) as well as for the tie-in cross section 108021. These three cross sections were therefore included in the Existing Conditions model. The interpolated cross sections were not retained as they were not hydraulically necessary.

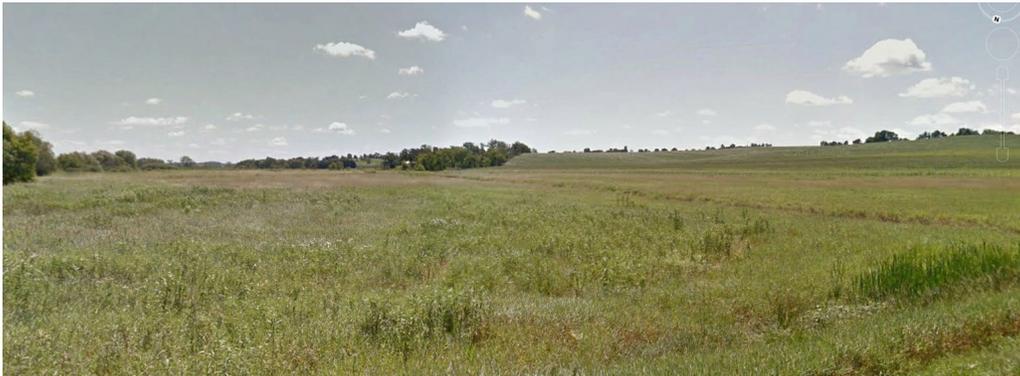
Figure 7. The floodplain overbanks are generally medium to dense brush

The downstream effective model uses Manning's n values of 0.085 to 0.09 in the denser tree areas, 0.07 to 0.06 in the brush areas, and 0.05 in agricultural areas. It is observed that the overbank areas in the new model are largely scrub shrub as seen in Figure 7. Thus, to be consistent with the downstream effective model, a conservative yet composite Manning's n value of 0.07 is applied in the overbank areas.

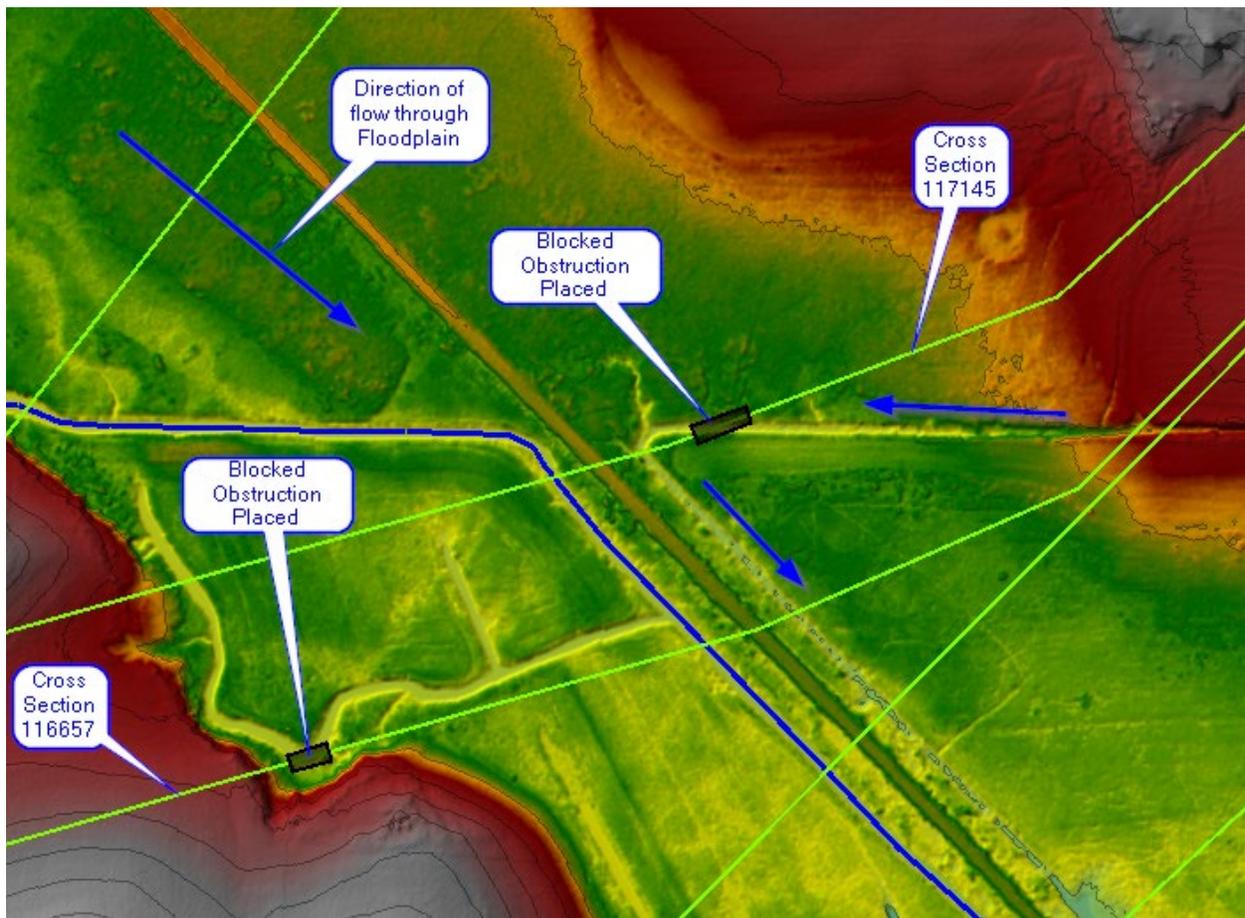
Figure 8. Existing conditions blocked obstructions

Additionally, canals exist throughout the overbank areas. Most of the canals are narrow and are determined to have a minor effect on the hydrodynamics. A blocked obstruction was placed at cross section 117145 to simulate the flow through a canal. Due to the same canal crossing this cross section twice, it was determined that blocking the portion that would be moving upstream (against the floodplain) would be appropriate as seen in Figure 8. An additional blocked obstruction was placed at a disconnected channel (Cross Section 116657) where the width and direction of the channel are not appropriate for effective flow. The elevation of the blocked obstructions are roughly placed at the LiDAR elevations to simulate the standing water surface elevation.

The main channel within the internal bridge cross sections were modeled using a Manning's n value of 0.04 to be consistent with the channel modeling upstream and downstream of the bridge. The internal bridge overbank areas were modeled using a value of 0.05 to represent weeds and stones between the channel and bridge abutments.

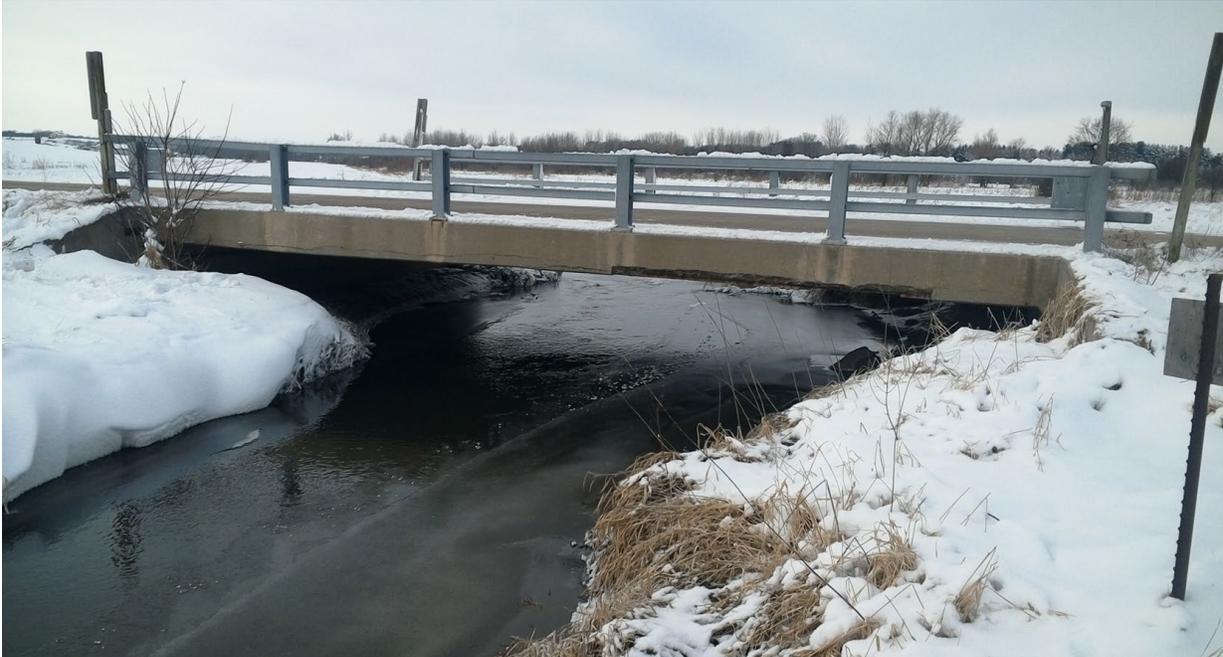
Figure 9. White Crossing Road Bridge span is 40 feet

At the upstream end of the Existing Conditions model, White Crossing Road was modeled. The 2022 survey data as well as Wisconsin Department of Transportation as-builts dated 1988 were utilized to incorporate the structure in the model. The main bridge spans approximately 40 feet (Figure 9). Additionally, two 48-inch by 66-inch diameter culverts are located to the east of the bridge (Figure 10). This crossing is overtopped during the 100-year flood event and is modeled under pressure flow. Internal cross sections were used to refine the topography at the culvert inverts to effectively model the culverts.

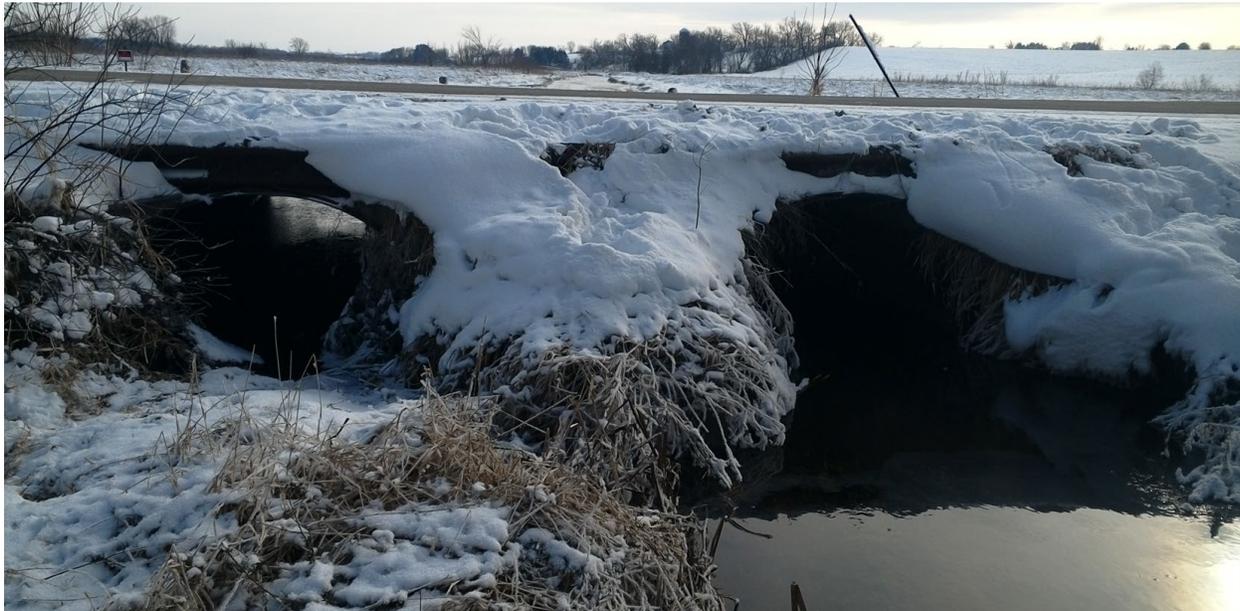
Figure 10. White Crossing Road 48-inch by 66-inch culverts

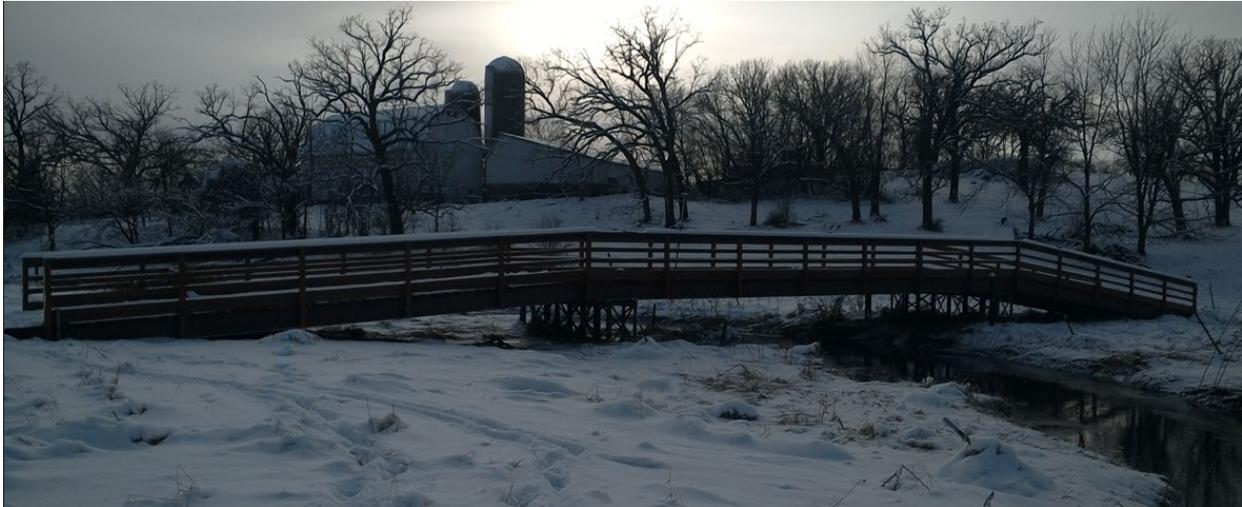
Figure 11. Modeled Metal Bridge

A small metal footbridge in the floodplain is modeled and is shown in Figure 11. This footbridge is located (at river station 120554) approximately 2700 feet downstream from the White Crossing Road (at river station 123256). Survey shots were used to model the deck of the bridge and two piers. This crossing is overtopped in the 100-year profile and is modeled under pressure flow.

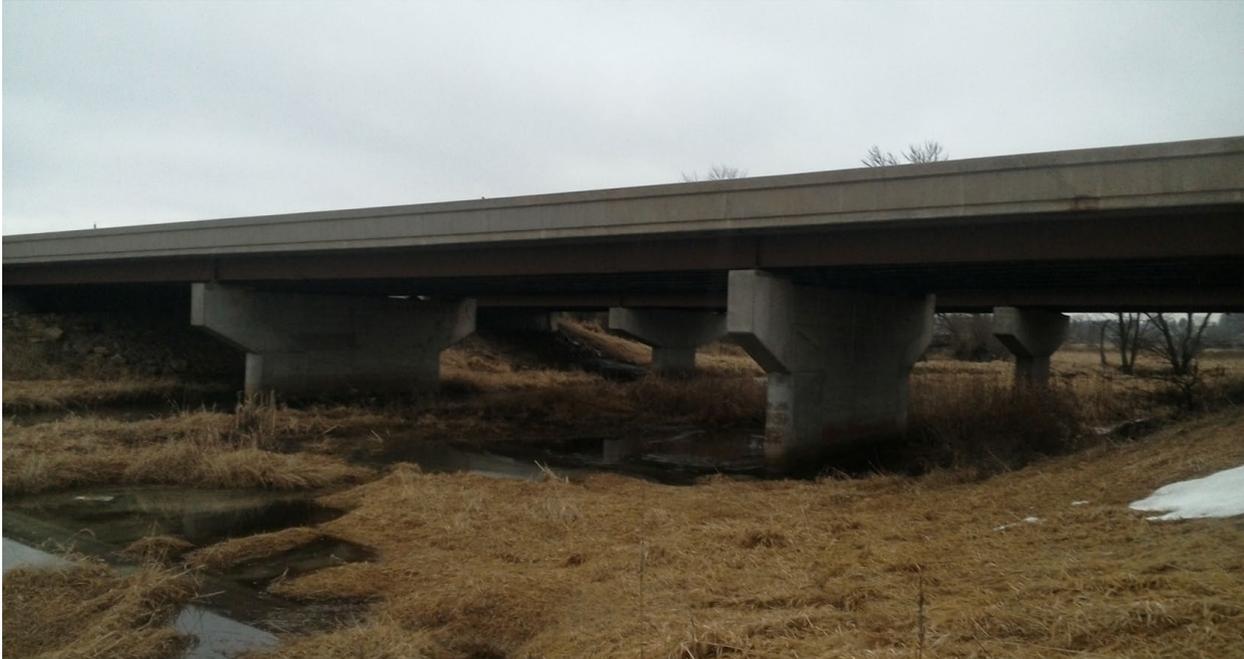
Figure 12. USH 18/151 Crossing Bridge

The USH 18/151 crossing consists of a bridge and two culvert groups in HEC-RAS. In addition to the Sugar River, the Military Ridge State Trail (MRST) passes under USH 18/151 as well as a 48-inch Reinforced Concrete Pipe (RCP) for drainage in the left overbank. The USH 18/151 bridge spans roughly 150 feet of the Sugar River and contains two piers (Figure 12). These are modeled as elongated piers with semi-circular ends. The 2022 survey data as well as Wisconsin Department of Transportation as-builts dated 1991 are applied to inform the modeling of the bridge.

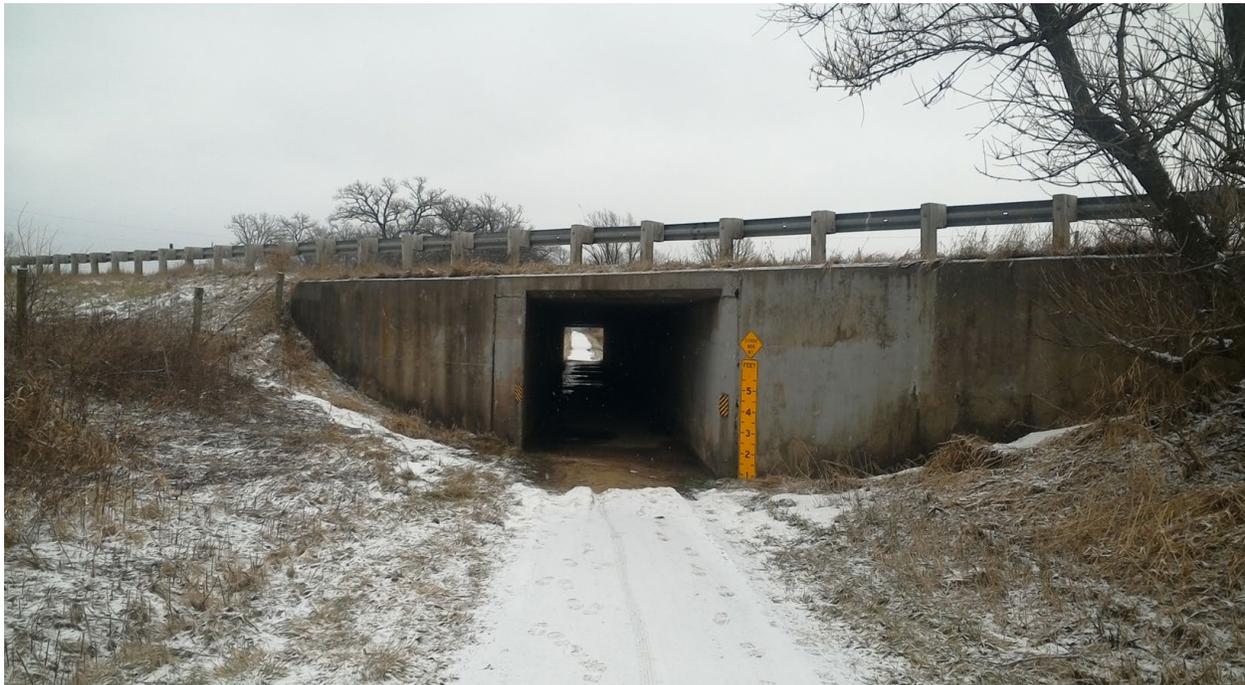
Figure 13. Military Ridge State Trail box culvert under the USH 18/151 Crossing

At the east end of the crossing, the MRST crosses USH 18/151 with a 10-foot by 9-foot reinforced concrete box culvert (Figure 13). Wisconsin Department of Transportation as-builts dated 1991 and new survey data is used to inform the geometry of the pedestrian tunnel. Finally, a 48-inch RCP culvert with an apron endwall is modeled about halfway along the crossing. Survey data was used to inform the modelling of this culvert. Internal cross sections were used to refine the topography at inverts to effectively model the MRST and culverts.

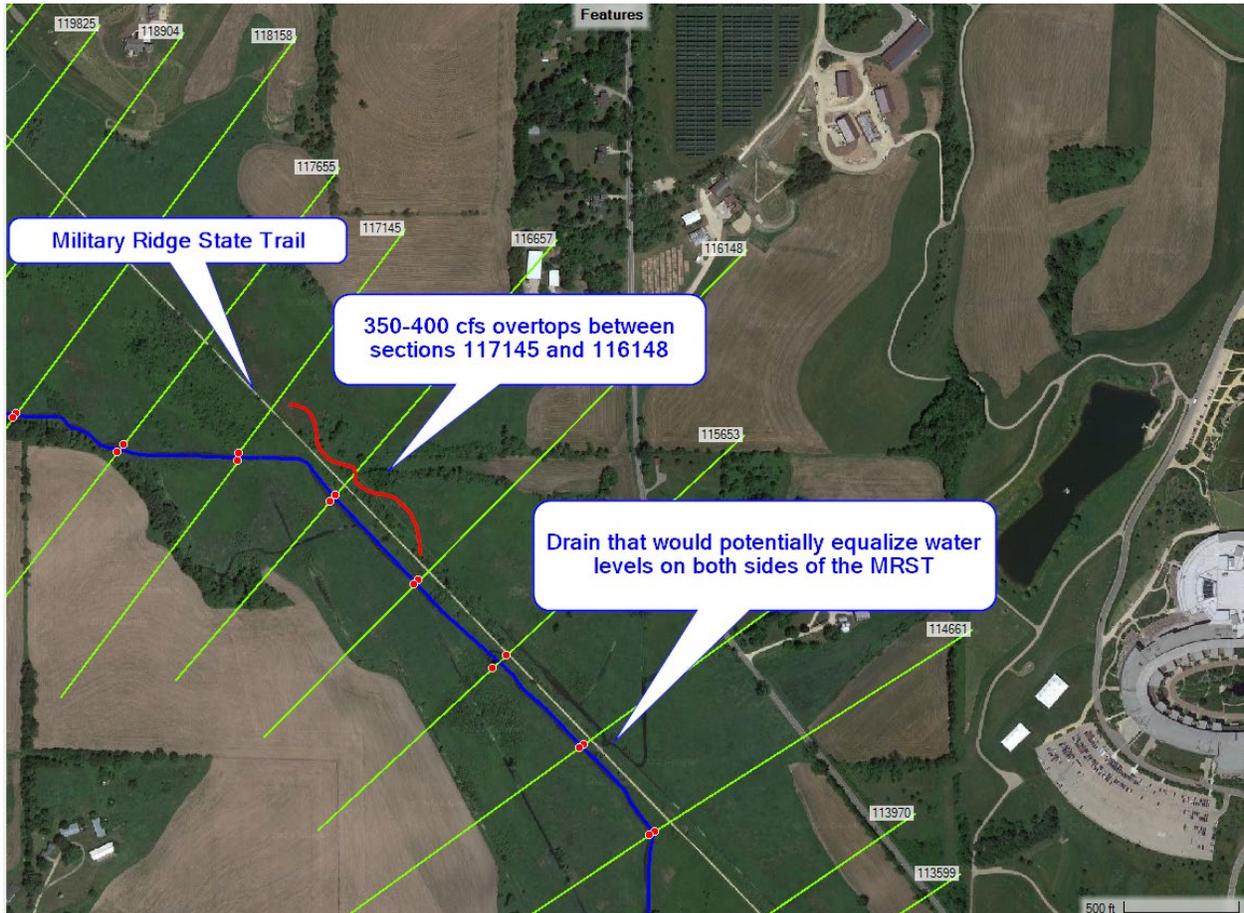
Figure 14. 350-400 cfs overtops the low spot on the Military Ridge State Trail near cross section 117145

To determine where the MRST overtops during the 100-year event and at what magnitude a scenario named "Ineffective Flow Determination" was created in HEC-RAS. A lateral structure was placed along the crest of the MRST in this area. A low spot in the crest of the MRST (figure 14) between sections 117145 and 116148 sees 350-400 cfs overtop during the 100-year event. This flow represents 15-17% of the total flow. Additionally, cross drains penetrate the MRST (Figure 15). These promote the equalization of water levels between the left and right side of the trail. Thus, it appears reasonable to model the east side of the MRST as fully effective flow starting at cross section 116148.

Based on the results of the lateral weir overtopping analysis, the effective flow area in the east side of the MRST is gradually expanded at a 2:1 ratio across the floodplain beginning between cross section 117655 and 117145. The entire cross section is fully effective by cross section 116148 for the 100-year event. Thus, upstream of section 117145, the ineffective elevation is set to the crest of the embankment, and at section 116148 and subsequent sections downstream, they are manually set below the 100-year water surface level. The trail is shown in Figure 14.

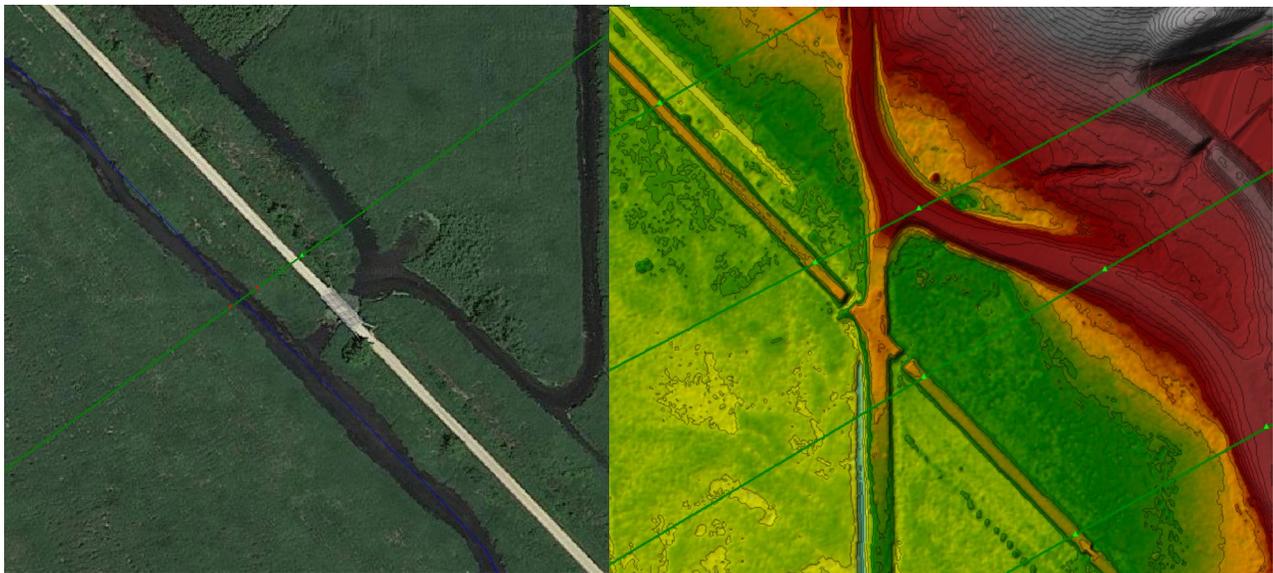
Figure 15. Drains that could potentially equalize water levels on either side of the MRST

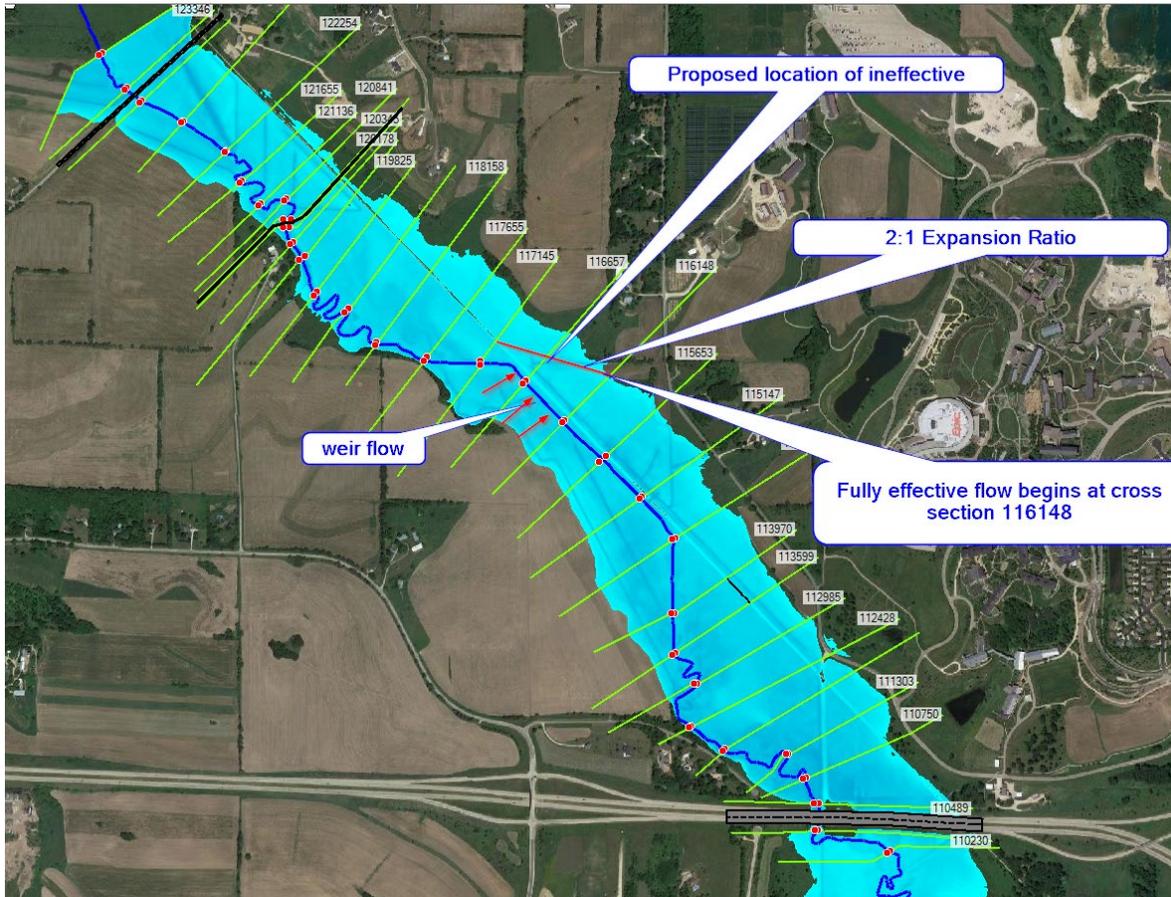
Figure 16. Raised ineffectives are placed to model expanding effective flow area downstream of cross section 117145

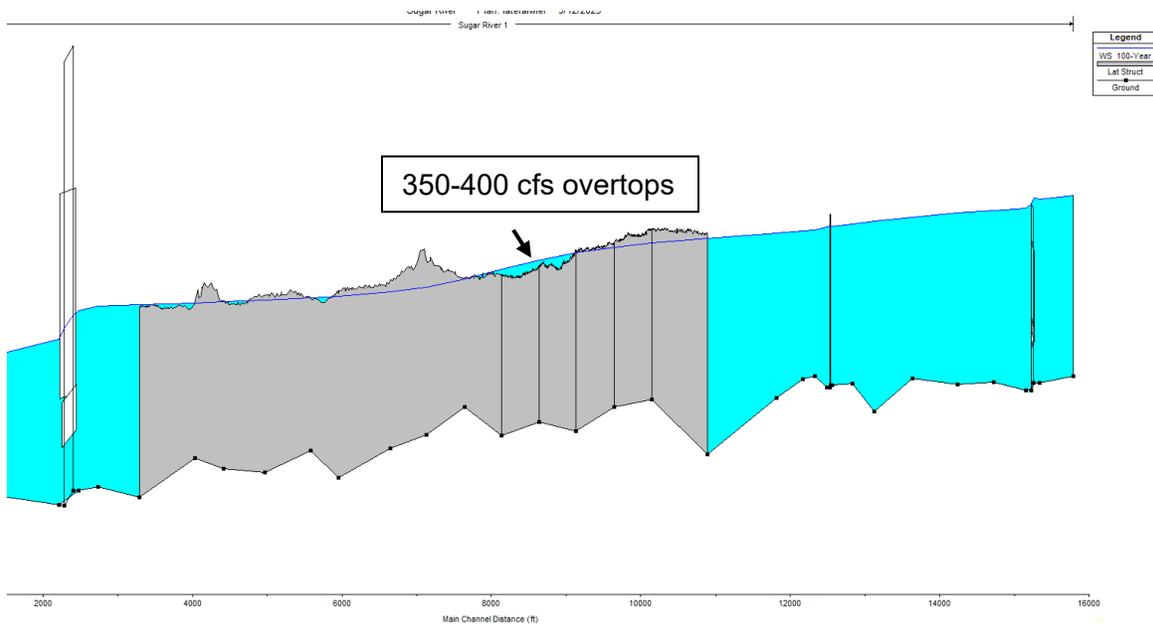
Figure 17. Profile of lateral weir placed in HEC-RAS

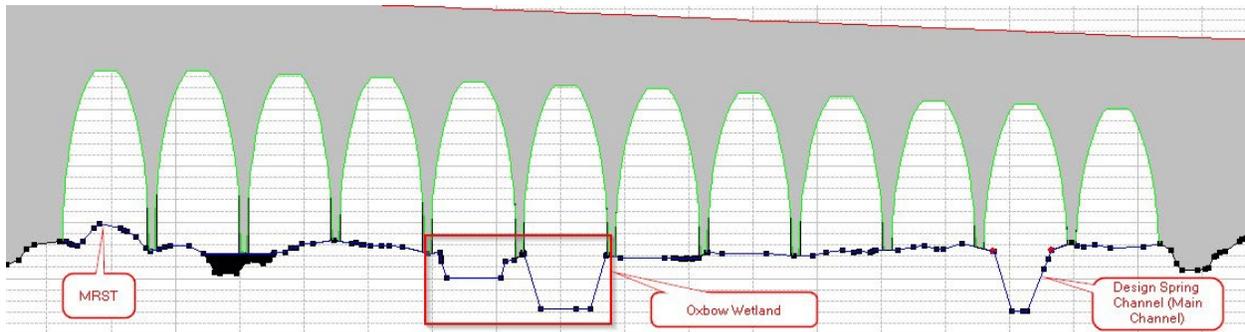
Figure 18. Proposed West Road Bridge Looking Downstream

The Proposed West Road crossing (River Station 116900) is a newly added structure. The proposed bridge crossing (see Figure 18) includes 12 precast openings (BEBO Concrete Arch) with each opening 54 feet (wide) by 16 feet (high). The far east opening is centered on the MRST trail with each additional opening centered 57.33 ft to the west. All openings are placed hydraulically perpendicular to the 100-year floodplain flow direction.

A design spring channel and oxbow wetland is proposed upstream and downstream of the proposed west road crossing to provide additional conveyance through the structure and maintain the natural stream conditions through the spring channel (see figure 20). The spring channel is considered the main channel and flows between cross sections 117655 and 116148. An oxbow wetland (disconnected wetland) provides additional conveyance for large storm events between cross sections 117655 and 116148. Through the proposed bridge crossing, the main spring channel and oxbow wetland channel are separated through multiple precast openings as seen in Figure 18.

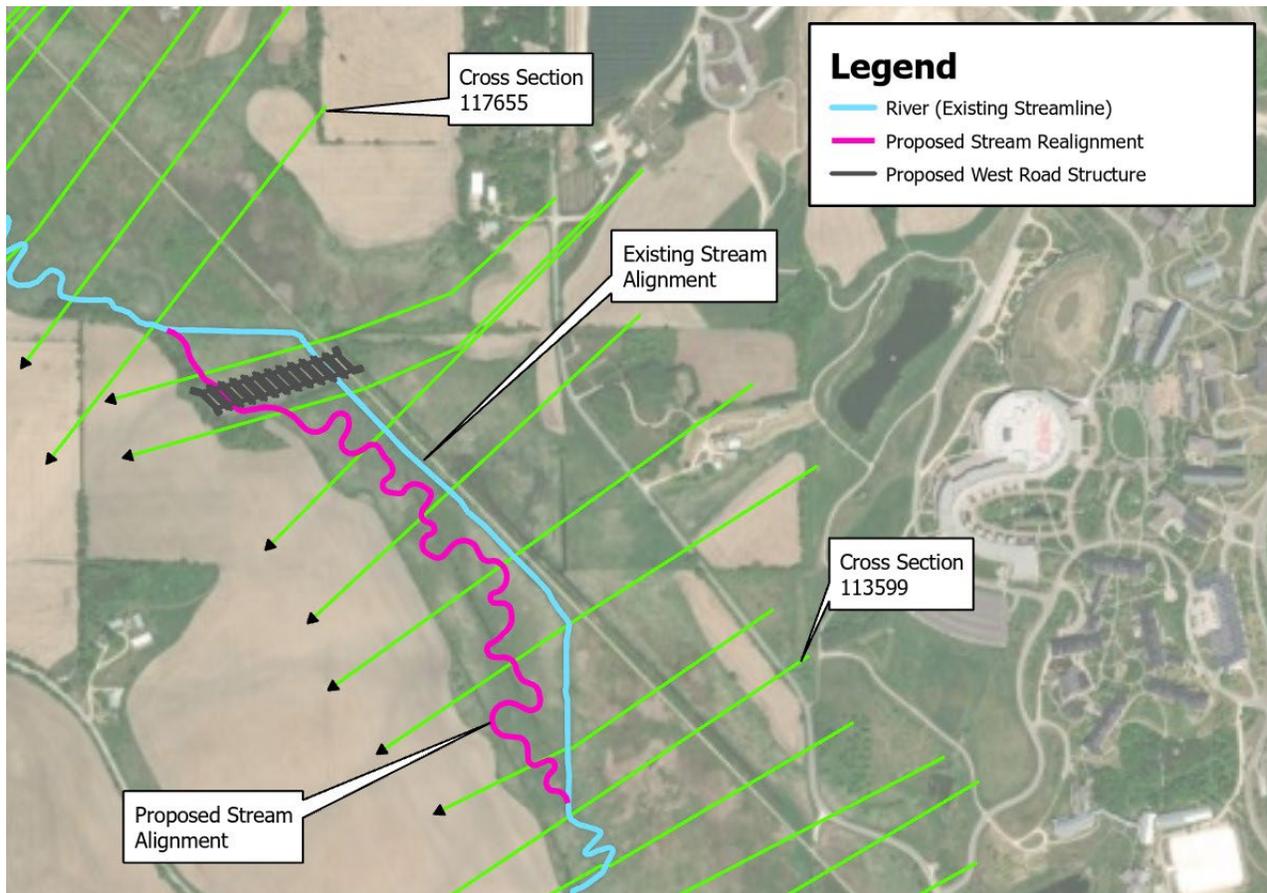
Figure 19. Comparison of Existing and Proposed Stream Alignment

The proposed stream restoration begins upstream of cross section 117145 and continues downstream until tying into the existing channel at cross section 113599. The stream restoration consists of returning the channelized stream into a stream that approximates pre-disturbance conditions and establishes conditions to support natural processes. These changes as pertaining to the model includes an updated stream channel geometry, lengthened stream channel alignment (due to the meandering channel), decreased channel slope, and Manning's n adjustments (see section 5.4.2) for the channel. See Figure 19 to see a comparison of the existing and proposed stream alignment.

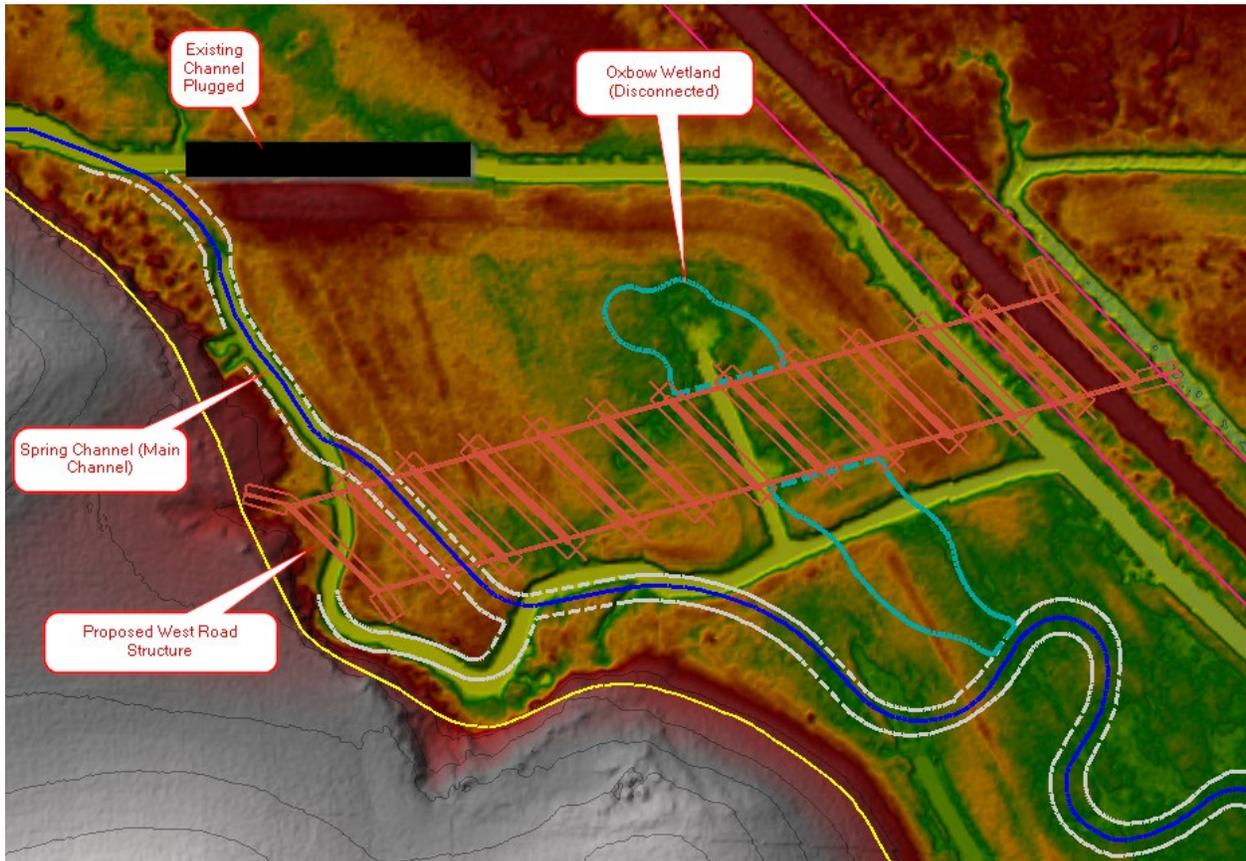
Figure 20. Proposed Stream Alignment through West Road
