Line 5 Wisconsin Segment Relocation Project Storm Water Pollution Prevention Plan

Line 5 Wisconsin Segment Relocation Project Wetland and Waterbody Delineation Report

Line 5 Wisconsin Segment Relocation Project Wetland and Waterbody Delineation Report 2020 Supplement

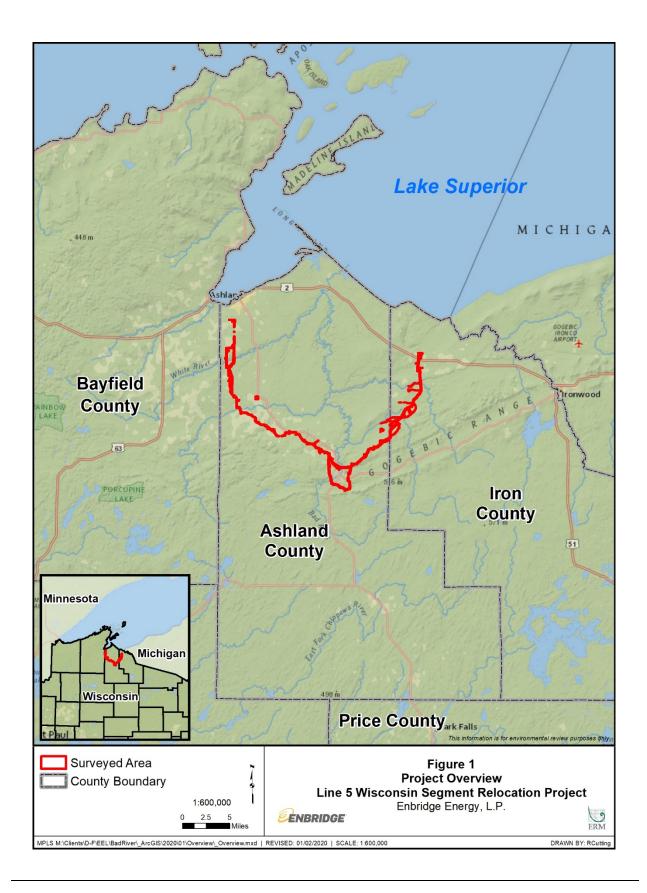
Wetland and waterbody surveys were conducted along accessible tracts located in Iron and Ashland Counties, Wisconsin (Figure 1). Field investigations were conducted from 29 August to 25 October2019. The credentials of the lead delineators are included in Appendix A.

- 2) Figure 1 on page 2 of the report text and Appendix I There appear to be breaks in the "surveyed areas". Were the breaks due to locations outside of the project area, or due to inaccessible tracts?
